Topo-Bathymetric Lidar and Photographic Survey of Various Bays located in New Brunswick, Nova Scotia and Prince Edward Island

Kate Collins, Tim Webster, PhD, Nathan
Crowell, Kevin McGuigan, Candace
MacDonald
Applied Geomatics Research Group
NSCC, Middleton
Tel. 902 825 5475
email: tim.webster@nsc.ca

March 30, 2016

Topo-Bathymetric Lidar and Photographic Survey of Various Bays located in NB, NS, and PEI

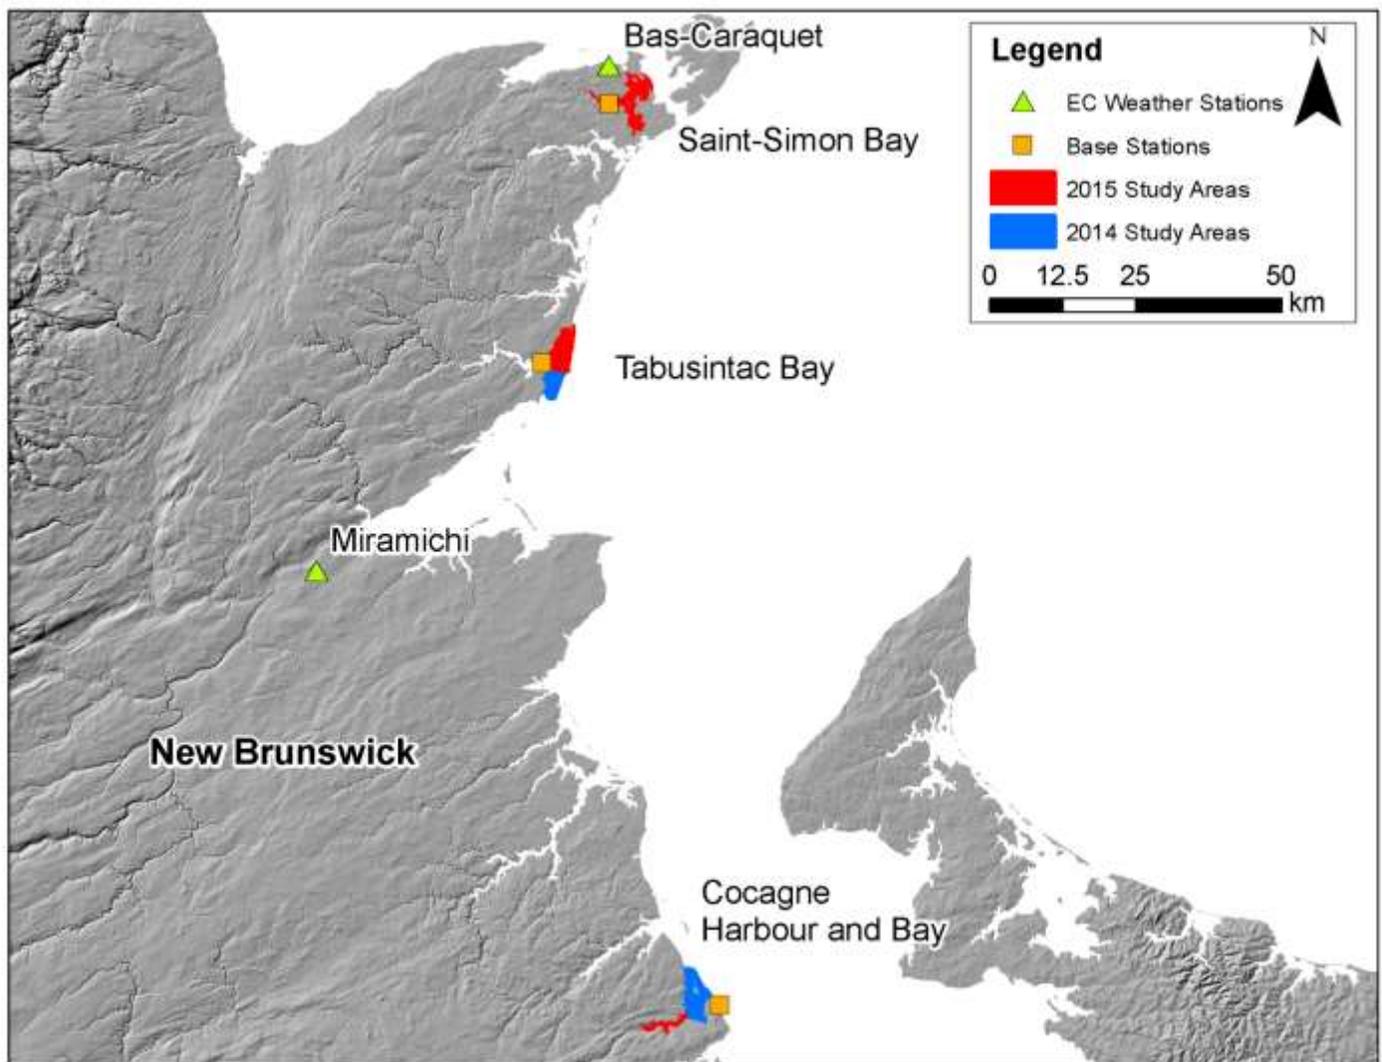
Figure 1.1: The topographic-bathymetric lidar study areas in the Southern Gulf of St. Lawrence surveyed in 2014 (blue) and 2015 (red) showing base stations (NB high precision network stations and a CHS benchmark, orange squares) and Environment Canada Weather Stations (green triangles).

The 2015 topographic-bathymetric lidar study areas built upon the areas completed in 2014 in the Southern Gulf of St. Lawrence region (Figure 1.1) and added a new area. Tabusintac Bay South was completed in 2014 for Public Works and Government Services Canada (PWGSC) and in 2015 the northern portion of the bay was surveyed for this project; Cocagne Harbour was surveyed in 2014 and in 2015 the river portion of the estuary was surveyed; Saint-Simon Bay North and South were both surveyed in 2015. These areas are all shallow inlets containing both eelgrass and shellfish aquaculture.

Ground truth data collection is an important aspect of topo-bathymetric lidar data collection. In 2015 we conducted our traditional “time-of-flight” ground truth data including hard surface validation and depth measurements to validate the lidar, Secchi depth measurements for information on water clarity, and underwater photographs to obtain information on bottom type and vegetation (Table 2, Figure 2.4). For the 2015 field season, we employed a new system to measure the seabed elevation directly using a large pole onto which we threaded the RTK GPS. This system helped to overcome the challenges of validating 1 m resolution lidar bathymetry using 3-5 m resolution code-based GPS to obtain the boat-based bathymetry spatial information. By threading the RTK GPS antenna on the pole and measuring the elevation of the seabed directly we not only benefitted from the higher resolution spatial data of the RTK GPS (2-5 cm accuracy), we also eliminated errors introduced into depth measurements obtained from a boat such as those caused by wave action, tidal variation, and angle of rope for lead ball drop measurements (Figure 2.4c). Table 2 summarizes the ground truth measurements undertaken for the three DFO PARR study areas in 2015, and Figure 2.5 shows a map of the distribution of ground truth measurements. Base stations are shown on Figure 1.1.

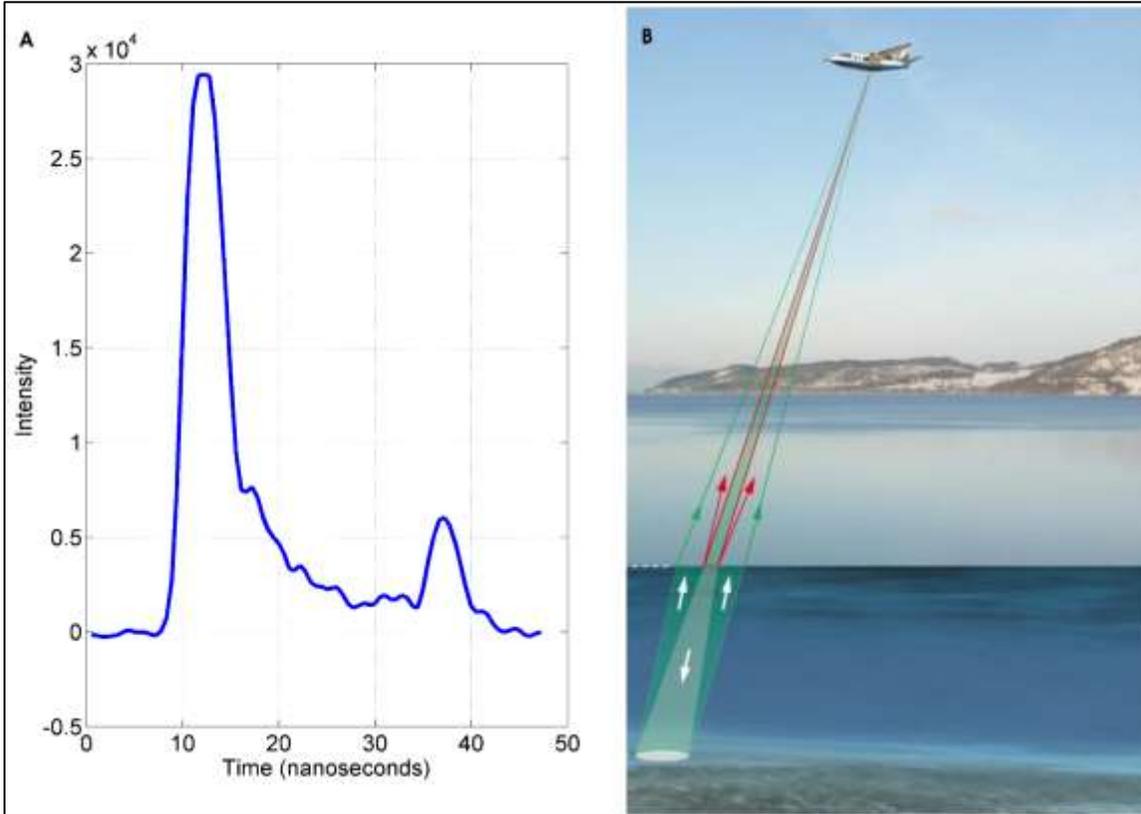
Figure 2.1: (A) Example of the Chiroptera II green laser waveform showing the large return from the sea surface and smaller return from the seabed. (B) Schematic of the Chiroptera II green and NIR lasers interaction with the sea surface and seabed (adapted from Leica Geosystems).

The lidar sensor used in this study is a Chiroptera II integrated topographic-bathymetric lidar sensor equipped with a 60 megapixel multispectral camera. The system incorporates a 1064 nm near-infrared laser for ground returns and sea surface and a green 515 nm laser for bathymetric returns (Figure 2.1). The lasers scan in an elliptical pattern, which enables coverage from many different angles on vertical faces, causes less shadow effects in the data, and is less sensitive to wave interaction. The bathymetric laser is limited by depth and clarity, and has a depth penetration rating of roughly 1.5 x the Secchi depth (a measure of turbidity or water clarity using a black and white disk). The Leica RCD30

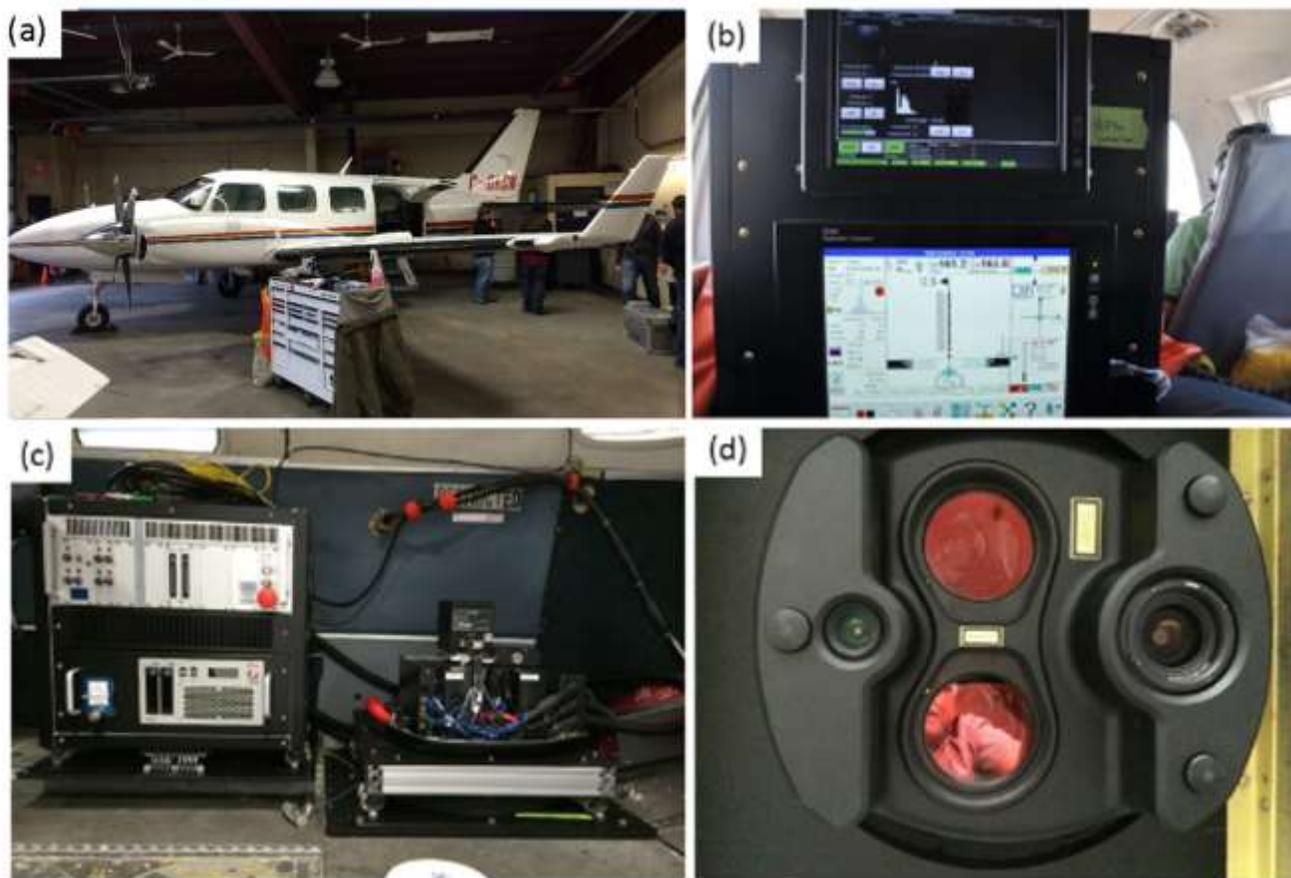
Figure 2.2: (a) Aircraft used for 2015 lidar survey; (b) display seen by lidar operator in-flight; (c) main body of sensor (right) and the data rack(left); (d) large red circles are the lasers; the RCD30 lens (right) and low resolution camera quality control(left).

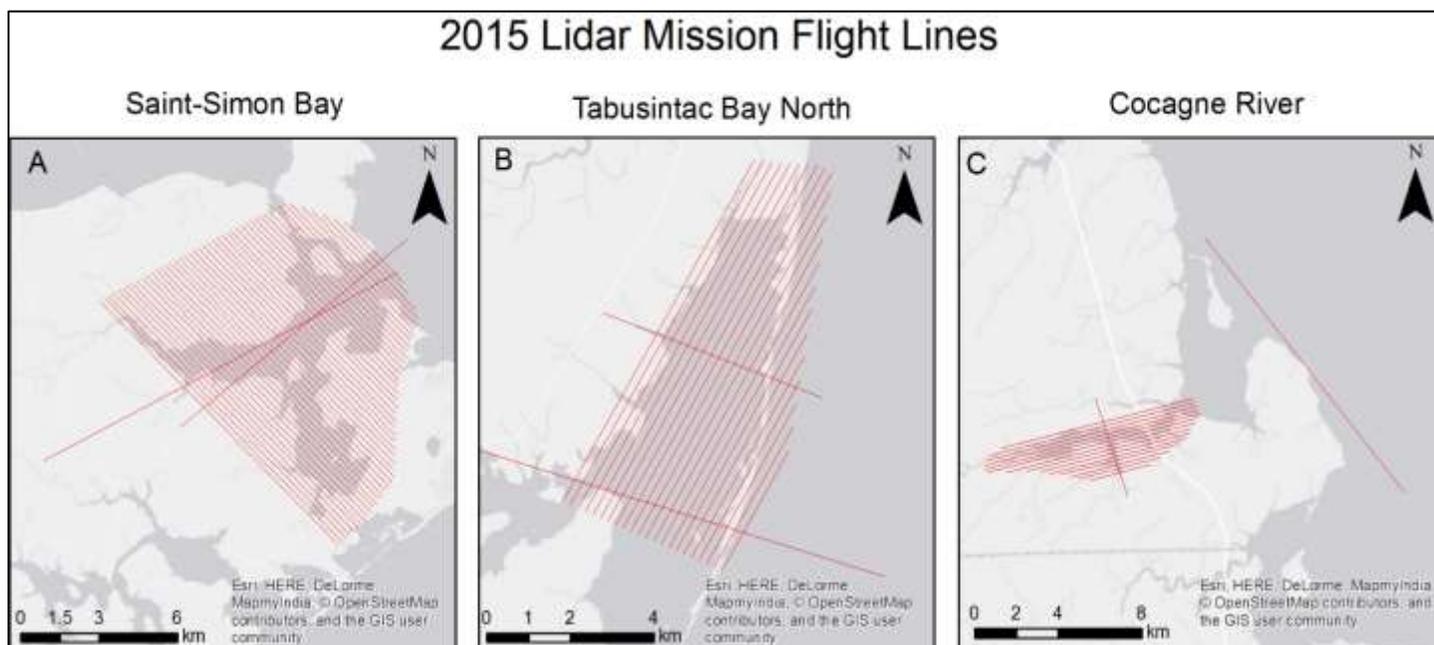
Figure 2.3: Flight lines planned for the 2015 study areas (A) Saint-Simon Bay, (B) Tabusintac Bay North, and (C) Cocagne River.

The lidar surveys were conducted in October and November, 2015 (Table 1). The surveys were planned using Mission Pro software and flown at an altitude of 400 m above ground at a flying speed of 62 m/s. The planned flight lines for each study area are shown in Figure 2.3. The aircraft required ground-based high precision GPS data to be collected during the lidar survey in order to provide accurate positional data for the aircraft trajectory. Our Leica GS14 RTK GPS system was used to set up a base station over a known monument (typically a New Brunswick High Precision Network (HPN) or a Canadian Hydrographic Service Benchmark). The GPS base station was set to log observations at 1 second intervals and the RTK rover was used to collect lidar validation points on hard flat surfaces (Figure 2.3).

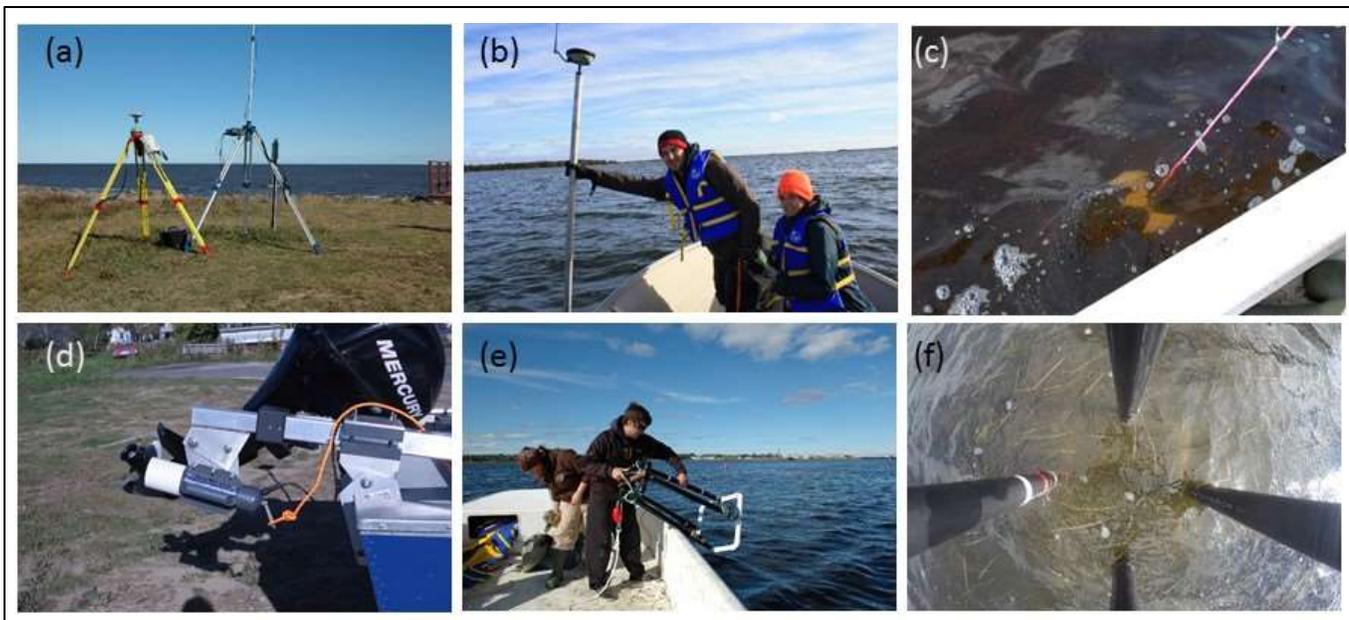
Figure 2.4: Ground truth images (a) GPS base station set up over HPN monument at Cocagne; (b) RTK GPS depth measurement using pole; (c) submerged Secchi disk; (d) Seaviewer underwater video camera; (e) 0.25 m² quadrat being deployed; (f) eelgrass at Tabusintac as photographed using quadrat.

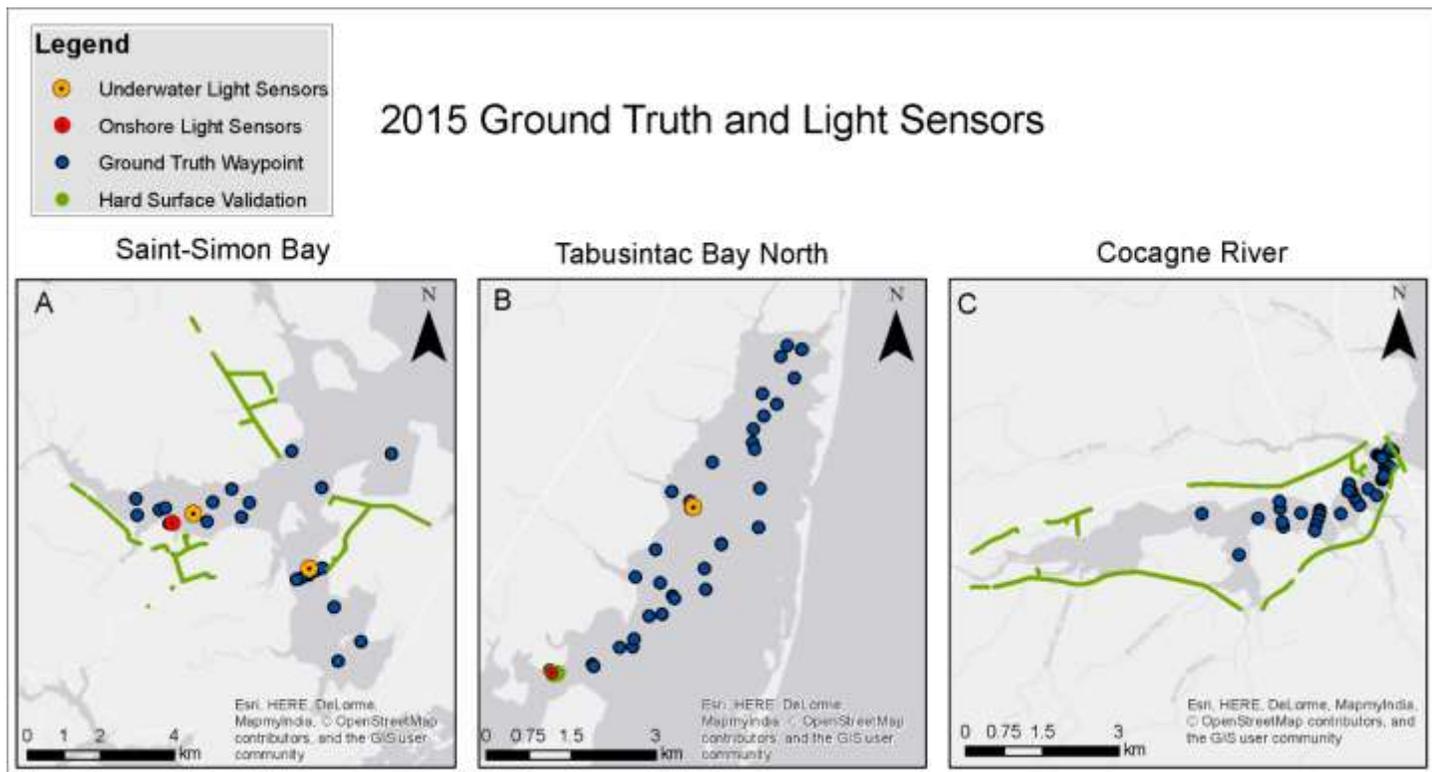
Figure 2.5: Location of hard surface GPS validation points, underwater and onshore light sensors, and boat-based ground truth waypoints at (A) Saint-Simon, (B) Tabusintac, and (C) Cocagne River. Note that no light sensors were deployed in Cocagne River, and there were no roads in the Tabusintac North study area for hard surface validation.

The 2015 ground truth campaign also included the deployment of underwater light sensors. The sensors were Onset HOBO Light and Temperature Pendant Sensors, which are wireless monitoring devices that can be deployed remotely for months at a time and will log data at user selected intervals. For this study, two of the Hobo sensors were secured to a cinder block (Figure 2.6) and deployed at two locations in Saint-Simon, and at one location in Tabusintac (Figure 2.5), approximately one month prior to the lidar surveys (Table 2). The RTK pole was used to store the location of the sensor deployment, and a rope was attached to a second block which was deployed nearby, so that the equipment could be retrieved by dragging the anchor or grapple between the two GPS points. The Saint-Simon northern light sensors and the Tabusintac sensors were retrieved following the lidar surveys, but field crews were unable to locate the Saint-Simon southern sensors (Figure 2.5).

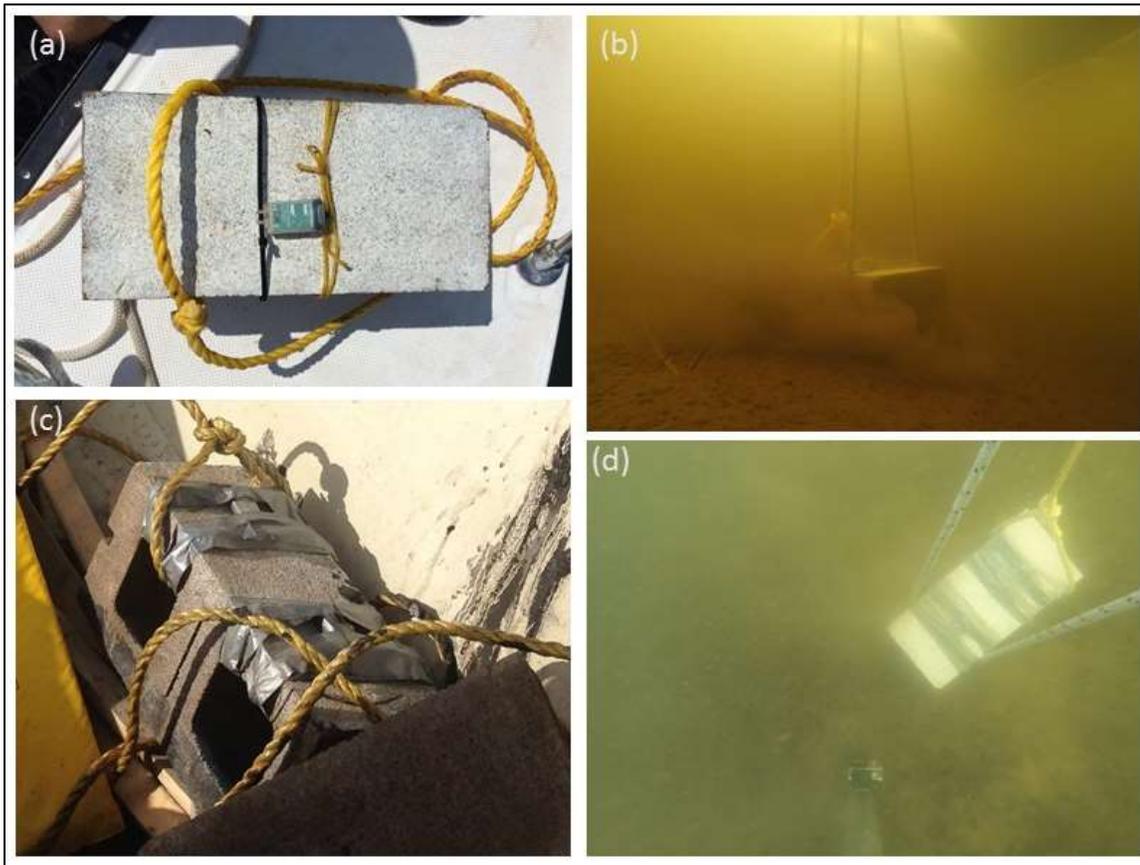
Figure 2.6: (a) A single light sensor secured to a cinder block (not used in PARR study areas); (b,d) underwater photo of cinder block and light sensor deployment at Tabusintac (b) and Saint Simon (d); (c) the light sensors after being retrieved from Tabusintac Bay in October.

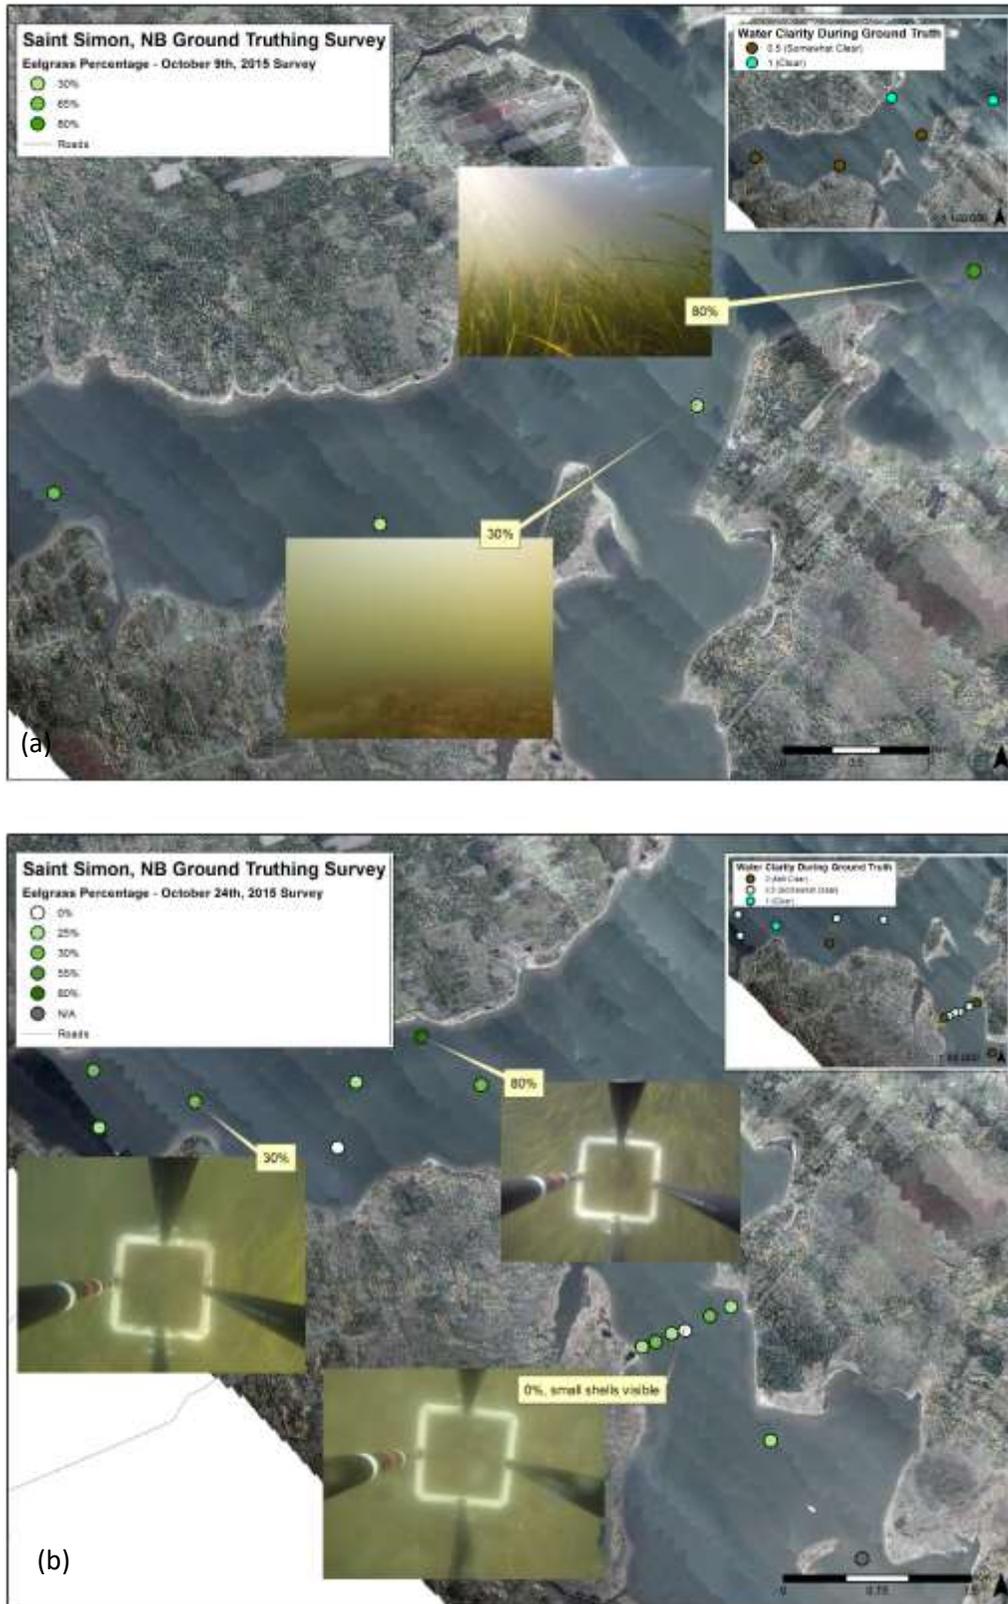
Figure 2.7: Saint Simon underwater photo ground truth on (a) October 9 and (b) October 24. N/A indicates no underwater photograph was taken, or the visibility was too poor to assess eelgrass presence. Background image is RCD30 orthophoto RGB mosaic.

Figure 2.7-Figure 2.10 show the locations of the underwater photographs conducted at Saint Simon, Tabusintac and Cocagne. The photos were used to assign each photo a value for percent eelgrass cover, based on the SeaGrassNet guidelines (<http://www.seagrassnet.org/>). Additionally, a qualitative visual inspection of the photos was completed to assign a water quality metric to each photograph, where 0 was indicative of water with very low clarity, 0.5 indicated medium clarity, or somewhat clear, and a rating of 1 indicated the water at that location at the time of the photograph was very clear. An eelgrass percent cover value of N/A indicates that water quality was too poor to detect any eelgrass.

At Saint-Simon, eelgrass percent cover was 0 in two locations, and ranged between 25% and 80% in the other 16 locations (Figure 2.7). Water clarity was generally somewhat clear or clear; only four locations were classified as 0, or not clear. At Tabusintac, eelgrass was only detected in one location on Oct. 26; poor water quality obscured the bottom and no classification of eelgrass was possible (Figure 2.8a). On Nov. 10, eelgrass percent cover ranged from 5-55% and was detected only on the eastern side of the bay, and water clarity remained poor on the western side of the bay (Figure 2.8b). The underwater video imagery indicated eelgrass percent cover between 0% near the channel and up to 30% near the center of the bay (Figure 2.9). At Cocagne eelgrass percent cover ranged from 0% in the channel to 95% elsewhere and water clarity ranged between poor and moderate quality (Figure 2.10).

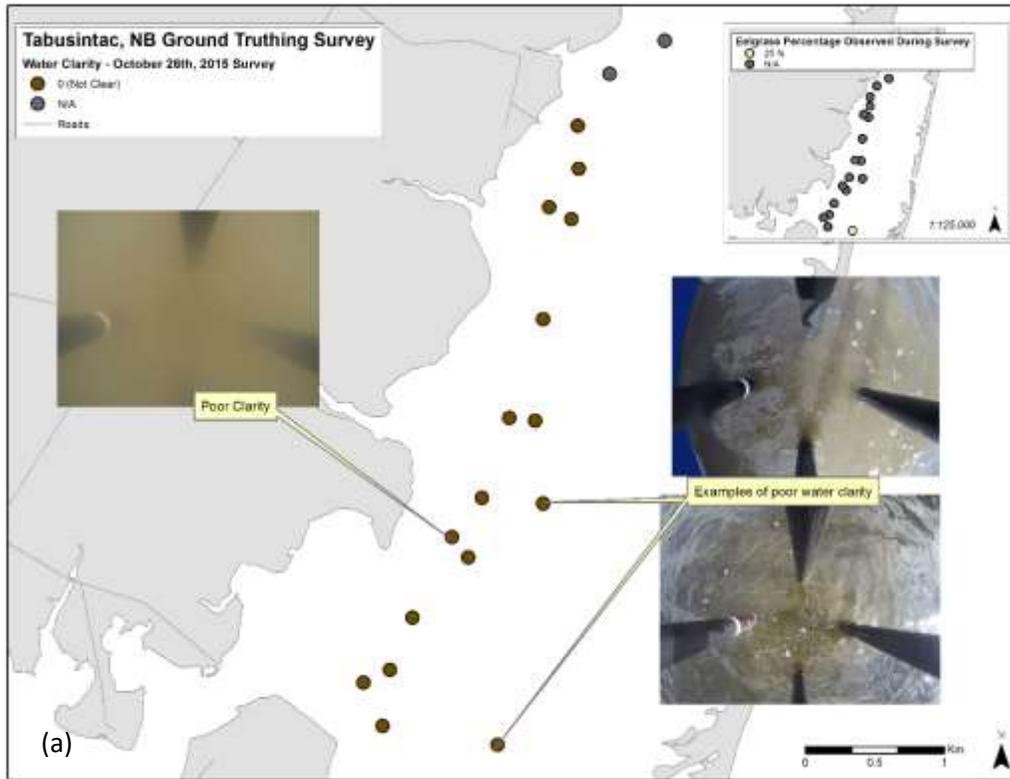
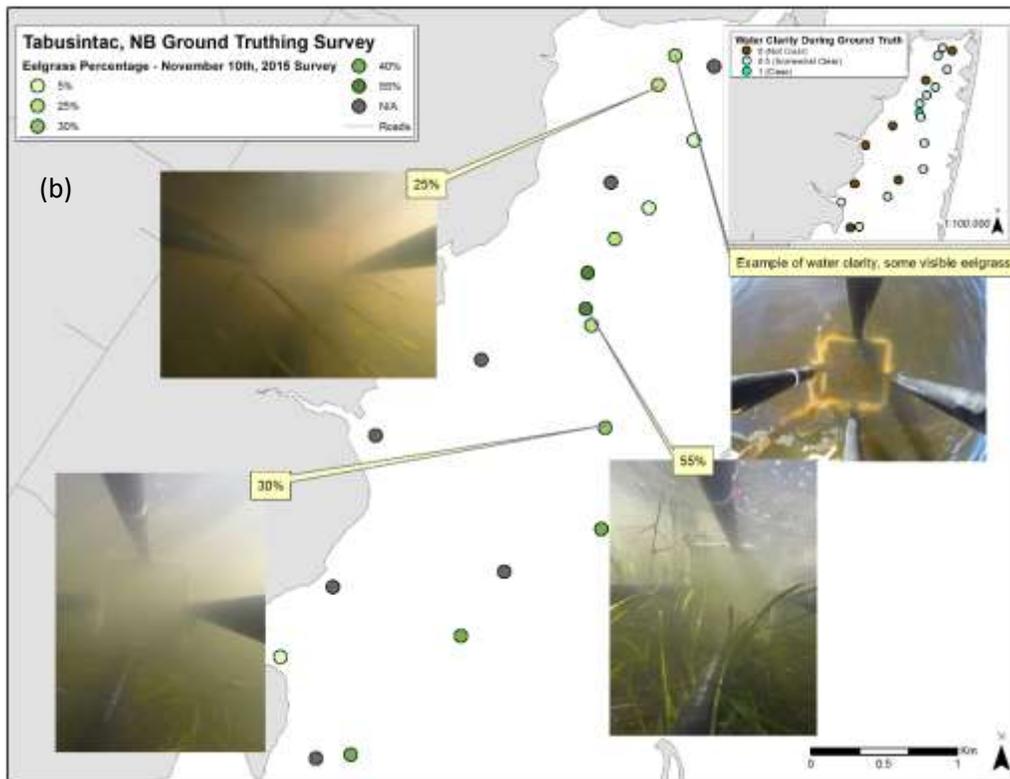
Figure 2.8: Tabusintac underwater photo ground truth on (a) October 26 and (b) November 10. N/A indicates no underwater photograph was taken, or the visibility was too poor to assess eelgrass presence.

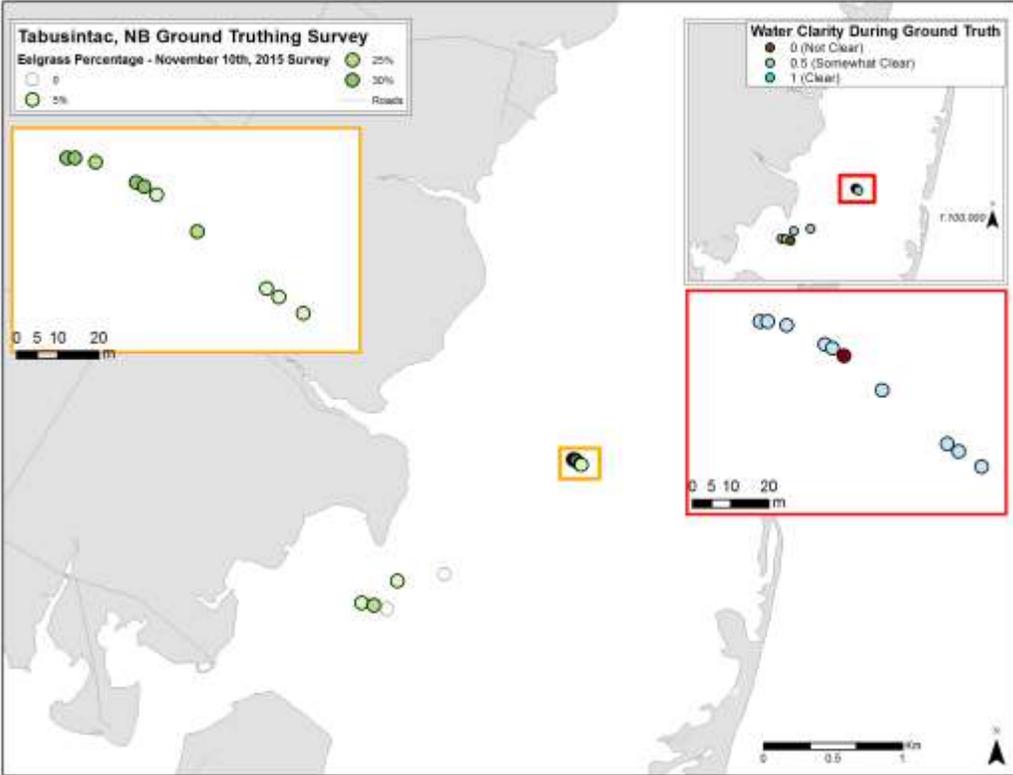
Figure 2.9: Tabusintac underwater video ground truth on October 7. Orange and red boxes are zoomed in on the transect at the center of the bay to show eelgrass (orange box) and water quality (red box).

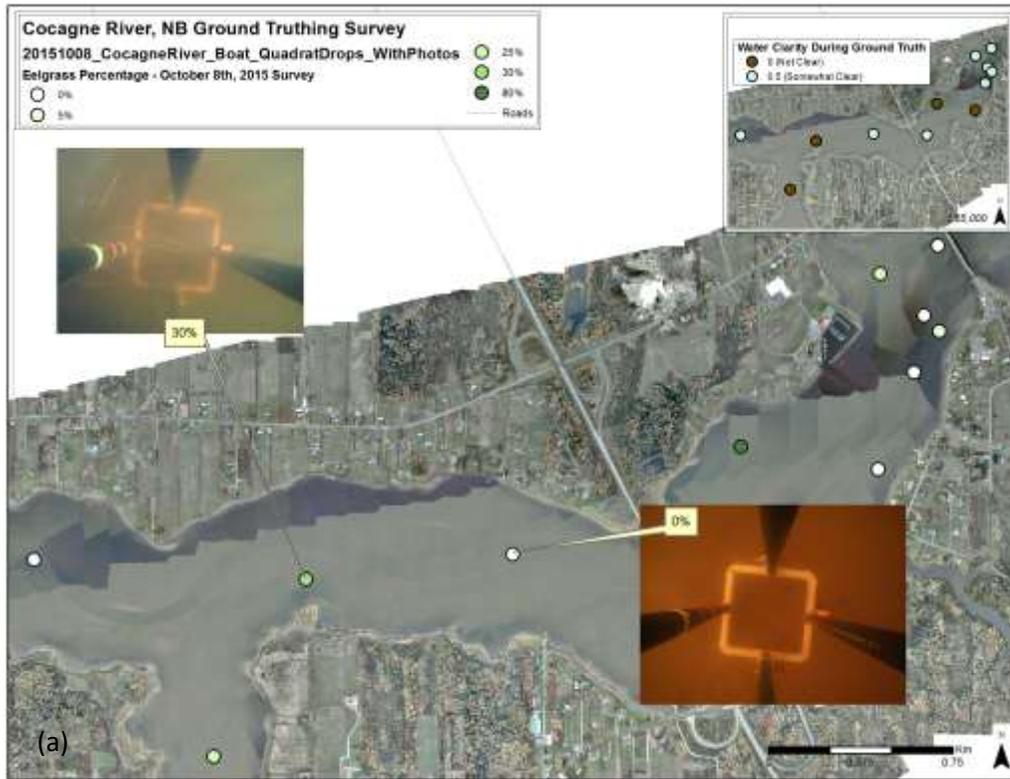
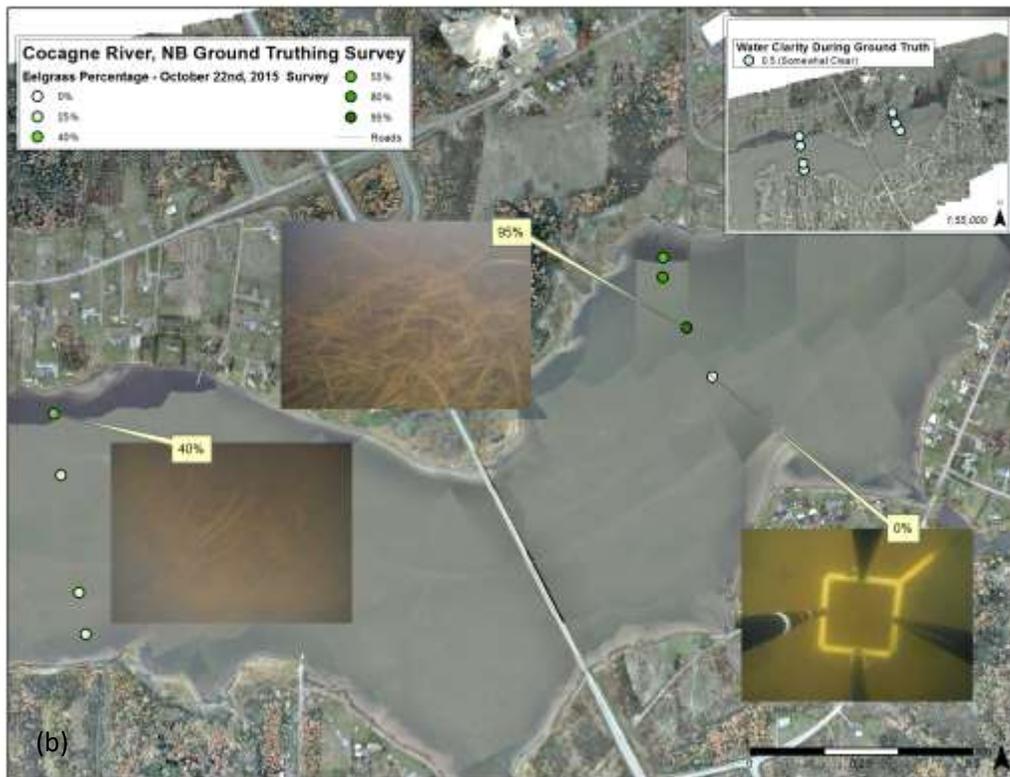
Figure 2.10: Cocagne River underwater photo ground truth on (a) October 8 and (b) October 22. N/A indicates no underwater photograph was taken, or the visibility was too poor to assess eelgrass presence. Background image is RCD30 orthophoto RGB mosaic.

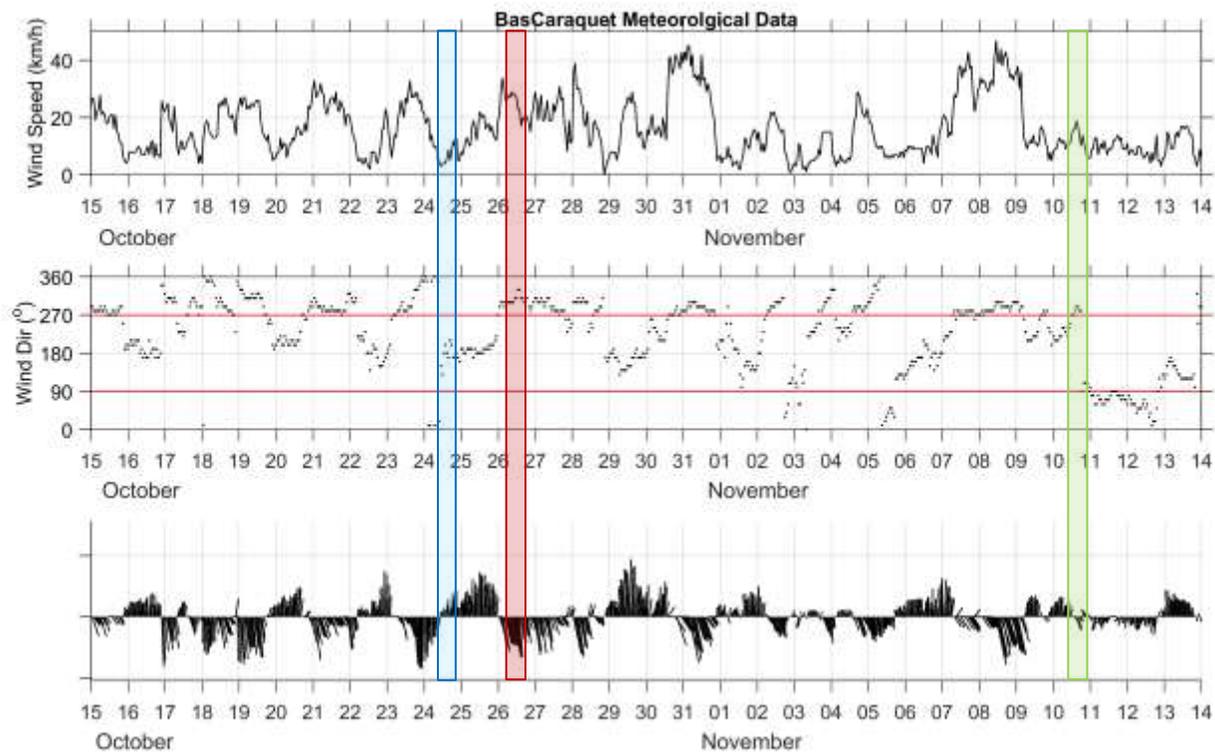
Figure 2.11: Wind speed (top panel) and direction (middle panel) collected at the EC weather station at Bas Caraquet between October 15 and November 14, 2015 at 1 hour intervals. The lower panel shows a stick plot of the wind, where the sticks point in the direction the wind is blowing, and the boxes indicates the lidar surveys (blue = Saint-Simon, red = Tabusintac Survey 1, green = Tabusintac Survey 2).

On October 26 at Tabusintac the wind at Miramichi was blowing from the northwest at nearly 20 km/hr (Figure 2.12, red box), and closer to 30 km/hr at Bas Caraquet (Figure 2.11, red box). It was expected that the study area, being in the northern section of Tabusintac Bay, would be sheltered somewhat from a northwest wind, which was forecast to be a lighter wind, and so the survey was completed. However, the sediment stirred up by the wind presented challenges for both the ground crew and the lidar data products. Figure 2.13a-c show the choppy water surface and poor water clarity on October 26. Upon review of the data after survey completion, it was decided that a second attempt would be made to survey Tabusintac. Operational and logistical challenges prevented survey activity during the calm weather in the first week of November, the survey was attempted for a second time on November 10. Wind conditions were similar at Bas Caraquet and Miramichi during the survey, blowing at ~20 km/hr from the northwest and changing to an eastern wind during the survey. Figure 2.13d shows the improvement in conditions during the second survey, despite the similarities in the wind speeds recorded during the two surveys. Unfortunately, the flight was aborted when it was two thirds completed due to a problem with the lidar system. Overcoming these challenges to lidar operational efficiency related to weather forecasts and publicly available observations is an active area of research at AGRG and is funded through an NSERC Applied Research and Development grant.

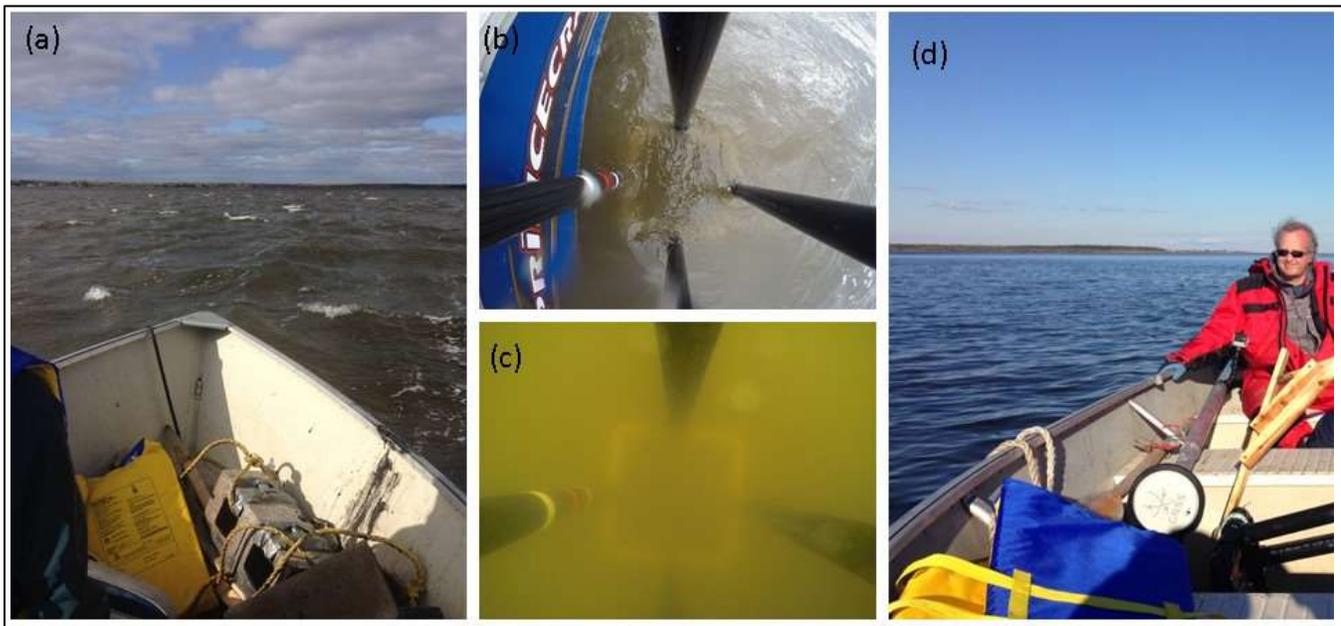
Figure 2.13: (a,b,c) Conditions at Tabusintac on October 26, where wind caused rough seas and reduced water clarity. (d) shows improved conditions on November 10 during the second survey.

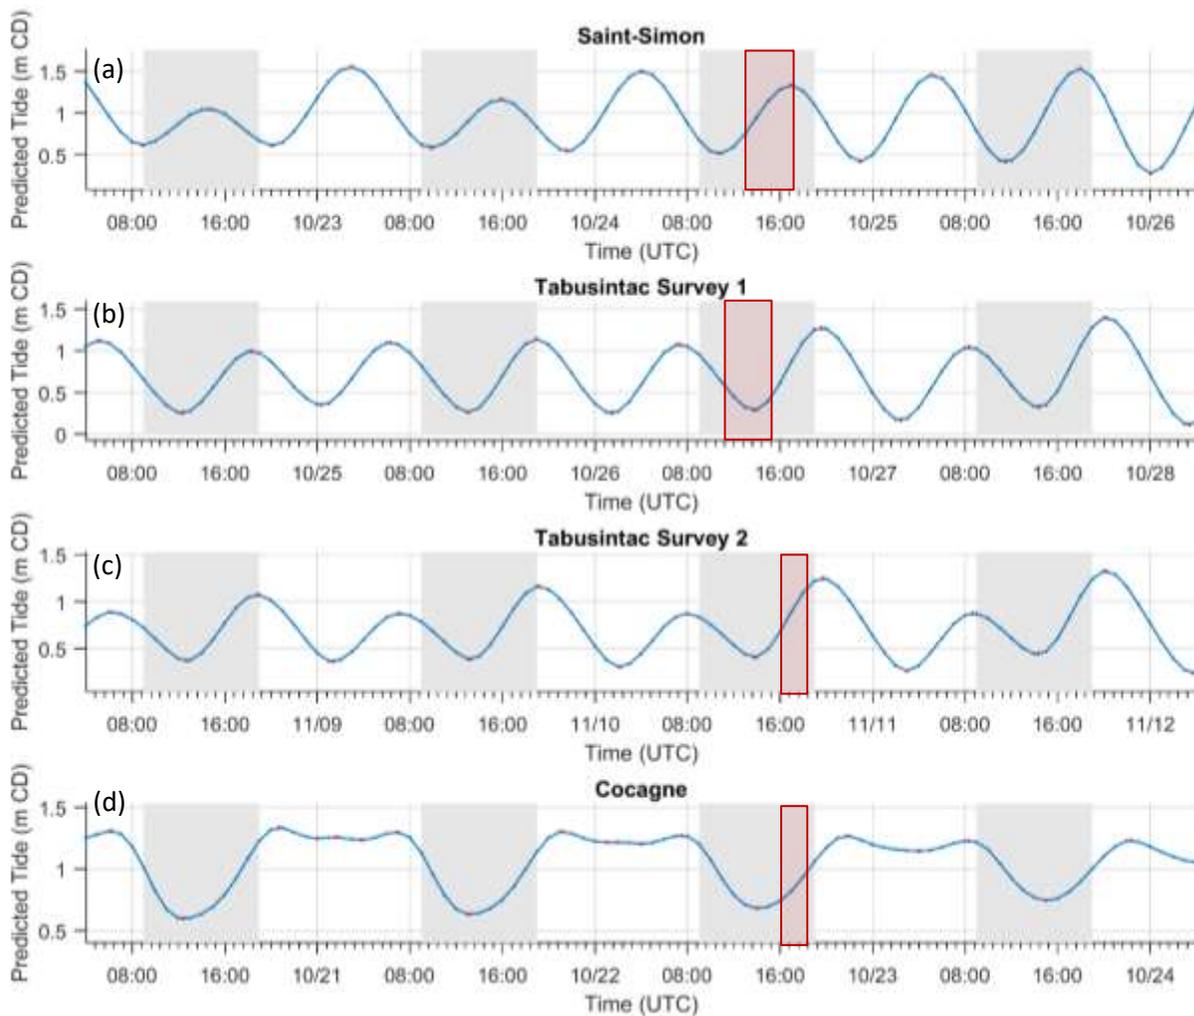
Figure 2.14: Tides for surveys at (a) Saint-Simon; (b) Tabusintac Survey 1; (c) Tabusintac Survey 2; (d) Cocagne. Grey bars indicate daylight hours and red boxes indicate survey durations.

Optimal data collection is a balance not only of water clarity and meteorological conditions, but also of daylight and tidal stage. The surveys were completed as near to low tide as weather and daylight permitted in order to reduce the amount of water that the laser was required to penetrate through in order to reach the seabed (Figure 2.14). On November 10 (Figure 2.14c) the second Tabusintac survey was delayed as long as possible as the forecast indicated lowest winds near the late afternoon, and the decision was made to optimize for low wind rather than low tide. At Cocagne (Figure 2.14d), the lowest tide was missed as the aircraft waited out some rain showers that were interfering with good lidar collection. Transit times to each study area from the base of operations in Fredericton played a role in when an area was surveyed, as well as time on the ground to refuel for larger areas (e.g., Saint-Simon).

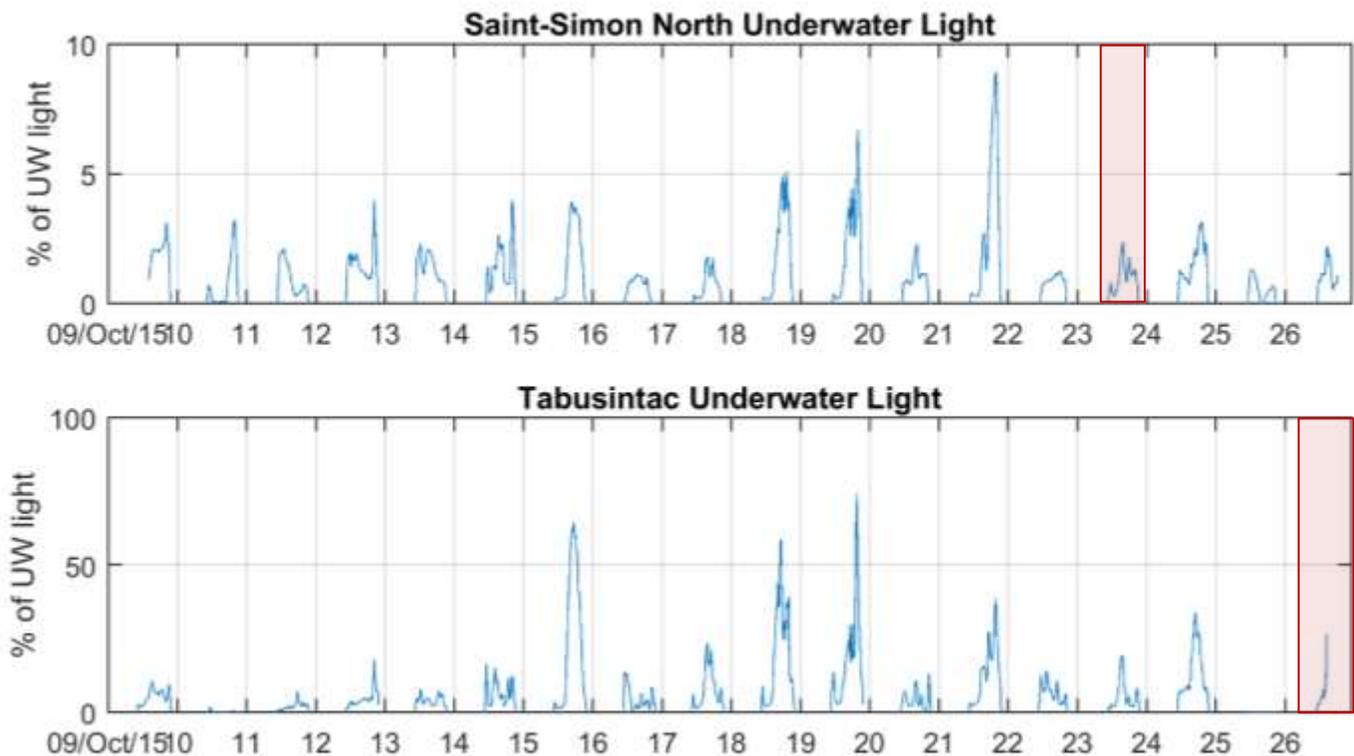
Figure 2.15: Light sensor data at (a) Saint-Simon North and (b) Tabusintac. The % of underwater light is underwater light divided by onshore light. Red boxes indicate lidar survey dates. The blue lines are an average of the two sensors which were placed on each cinder block.

where UW = underwater and OS=onshore. Figure 2.15 shows the variations in light due to water clarity and tide at Saint-Simon and Tabusintac; note the difference in y-axis at each study site. At Saint Simon, the sensors were deployed in approximately 3 m of water near low tide, and typically less than 5% of sunlight available at the surface reached the sensors. At Tabusintac the sensors were deployed in approximately 1 m of water at low tide and typically about 20% of light available at the surface reached the sensors.

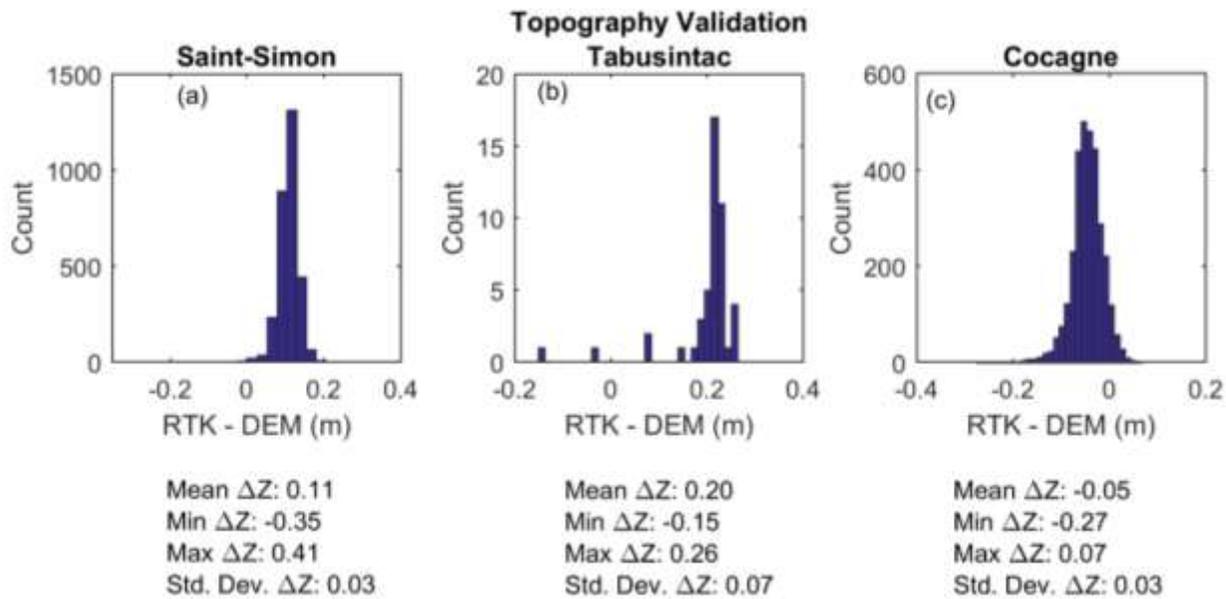
Figure 3.1: Topographic lidar validation for (a) Saint-Simon, (b) Tabusintac, and (c) Cocagne.

At Saint-Simon there were 3030 data points collected along the roads with a calculated mean ΔZ of $0.11 \text{ m} \pm 0.03 \text{ m}$; at Tabusintac there were 47 data points collected along the wharf and parking lot with a mean ΔZ of $0.20 \text{ m} \pm 0.07 \text{ m}$; at Cocagne there were 3154 data points collected along the roads, mean ΔZ was $0.05 \text{ m} \pm 0.03 \text{ m}$.

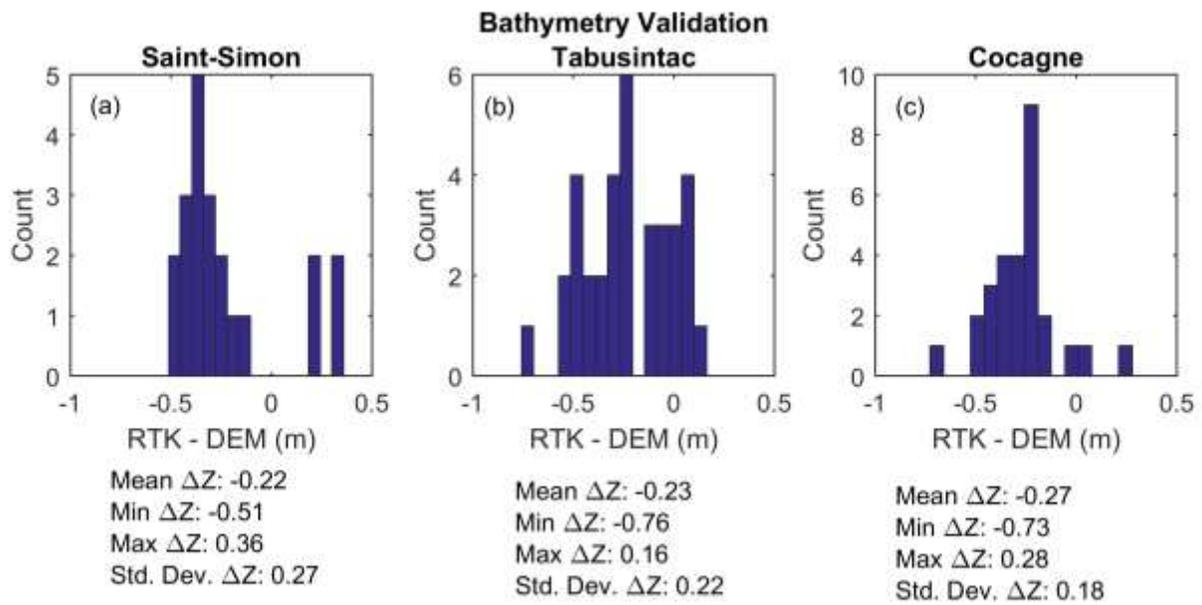
Figure 3.2: Bathymetric validation at (a) Saint-Simon; (b) Tabusintac; (c) Cocagne.

At all three study areas the mean ΔZ was negative, an indication that the DEM elevation is less (shallower) than the observed GPS point. At Saint-Simon, there were 21 GPS points, mean ΔZ was $-0.22 \text{ m} \pm 0.27 \text{ m}$; at Tabusintac there were 35 GPS points, mean ΔZ was $-0.23 \text{ m} \pm 0.22 \text{ m}$; at Cocagne there were 28 GPS points, mean ΔZ was $-0.27 \text{ m} \pm 0.18 \text{ m}$. It is possible that the bathymetric laser encountered difficulty in penetrating through the vegetation cover to the seabed, resulting in a derived seabed that is actually representative of the elevation of the eelgrass beds.
