Topo-Bathymetric Lidar and Photographic Survey of Various Bays located in New Brunswick, Nova Scotia and Prince Edward Island

Kate Collins, Tim Webster, PhD, Nathan
Crowell, Kevin McGuigan, Candace
MacDonald
Applied Geomatics Research Group
NSCC, Middleton
Tel. 902 825 5475
email: tim.webster@nsc.ca

March 30, 2016

Topo-Bathymetric Lidar and Photographic Survey of Various Bays located in NB, NS, and PEI

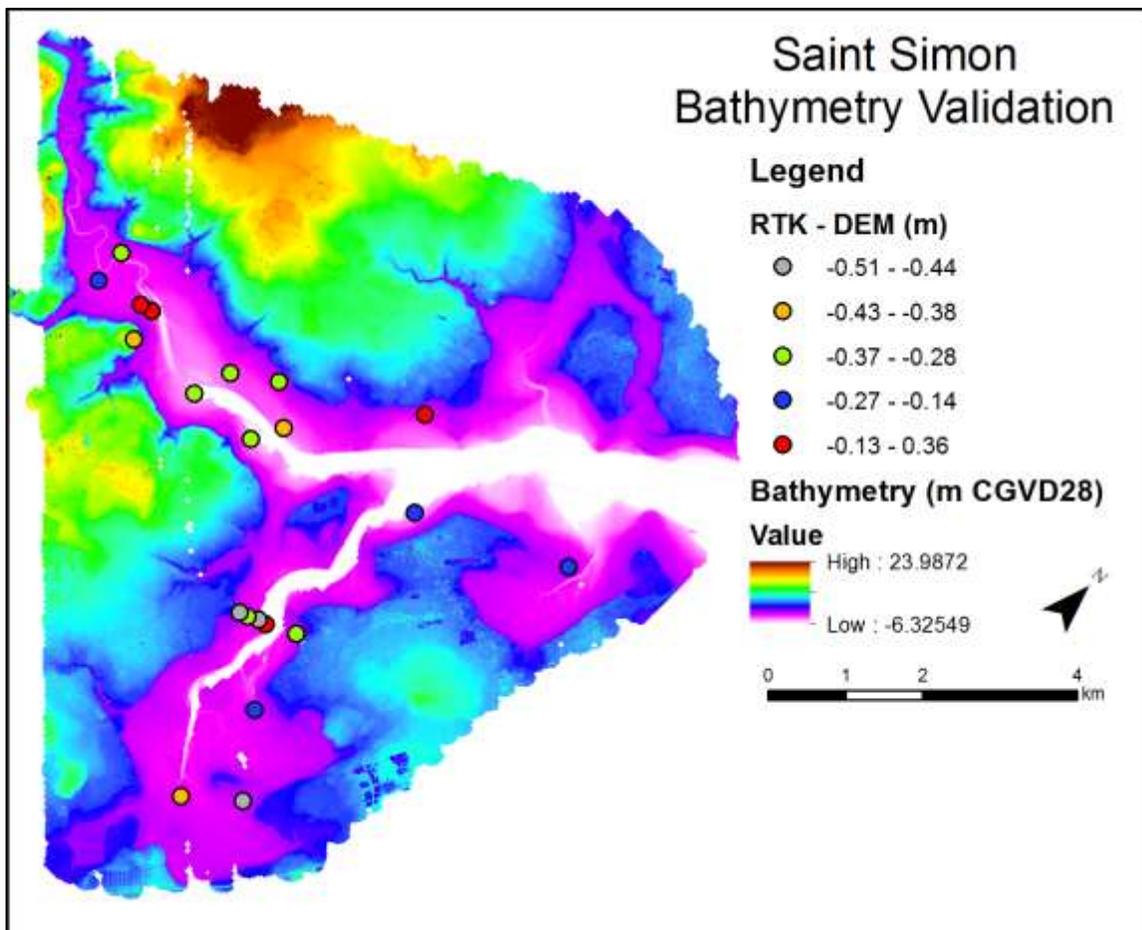
Figure 3.3: Saint Simon Bathymetry validation.

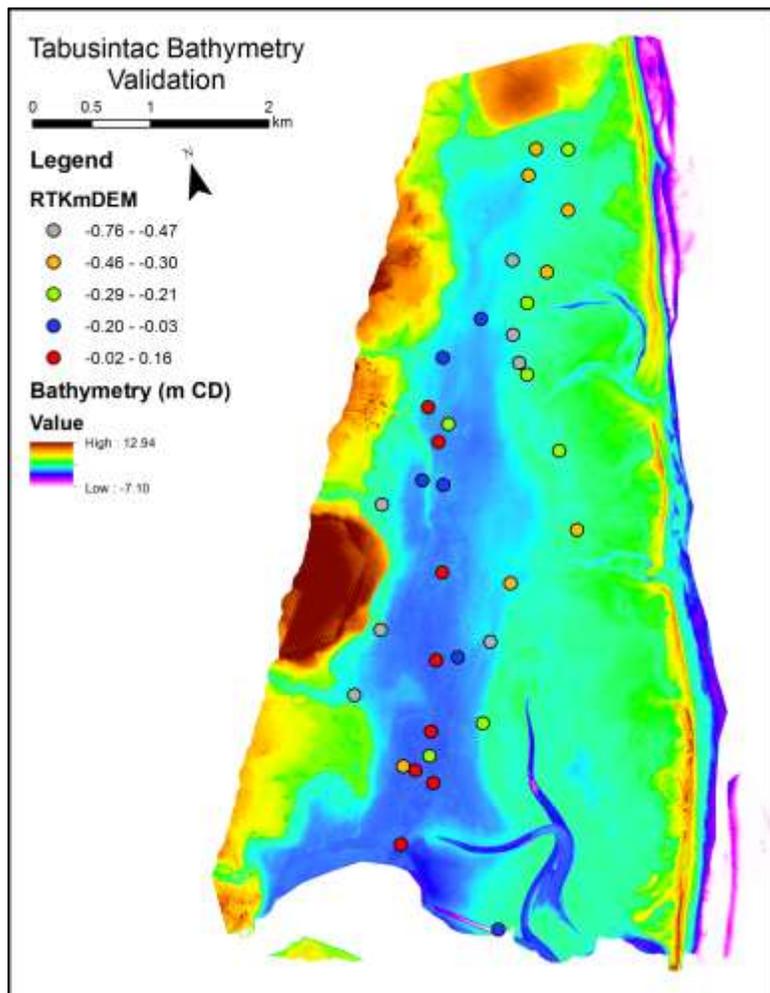
Figure 3.4: Tabusintac Bathymetric Validation.

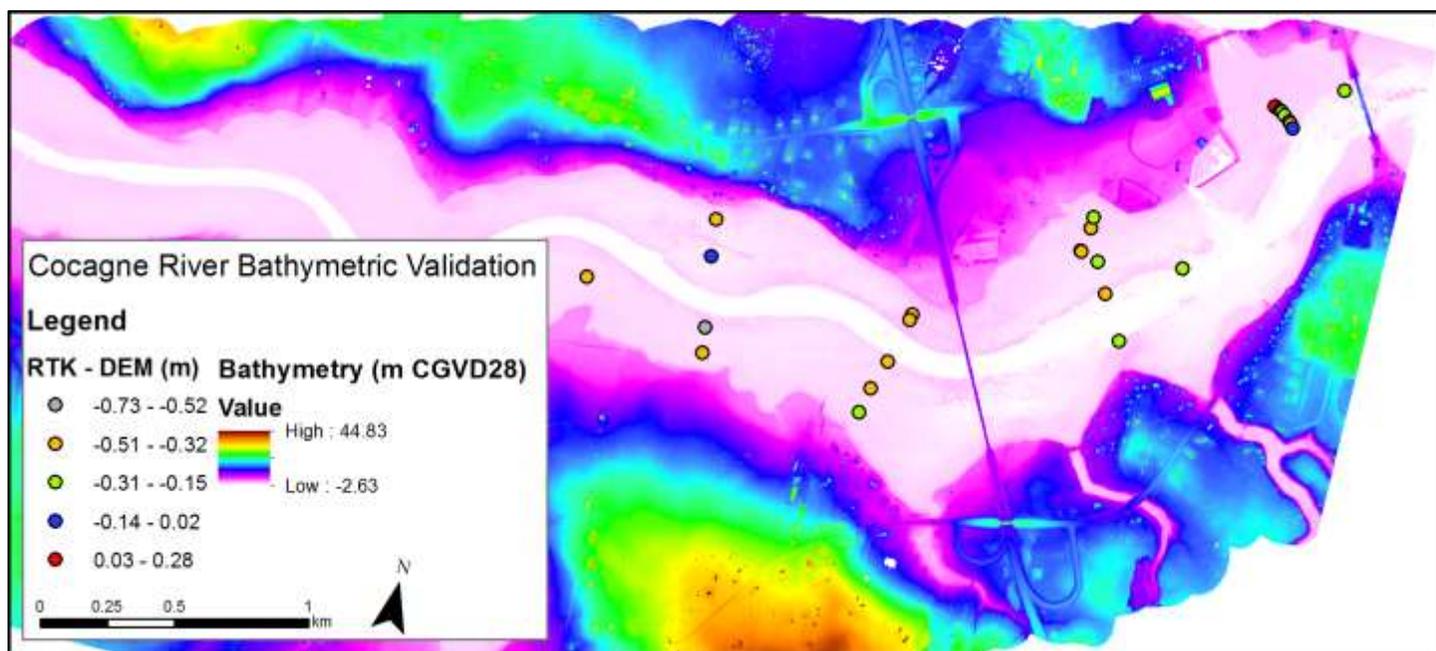
Figure 3.5: Cocagne Bathymetric Validation.

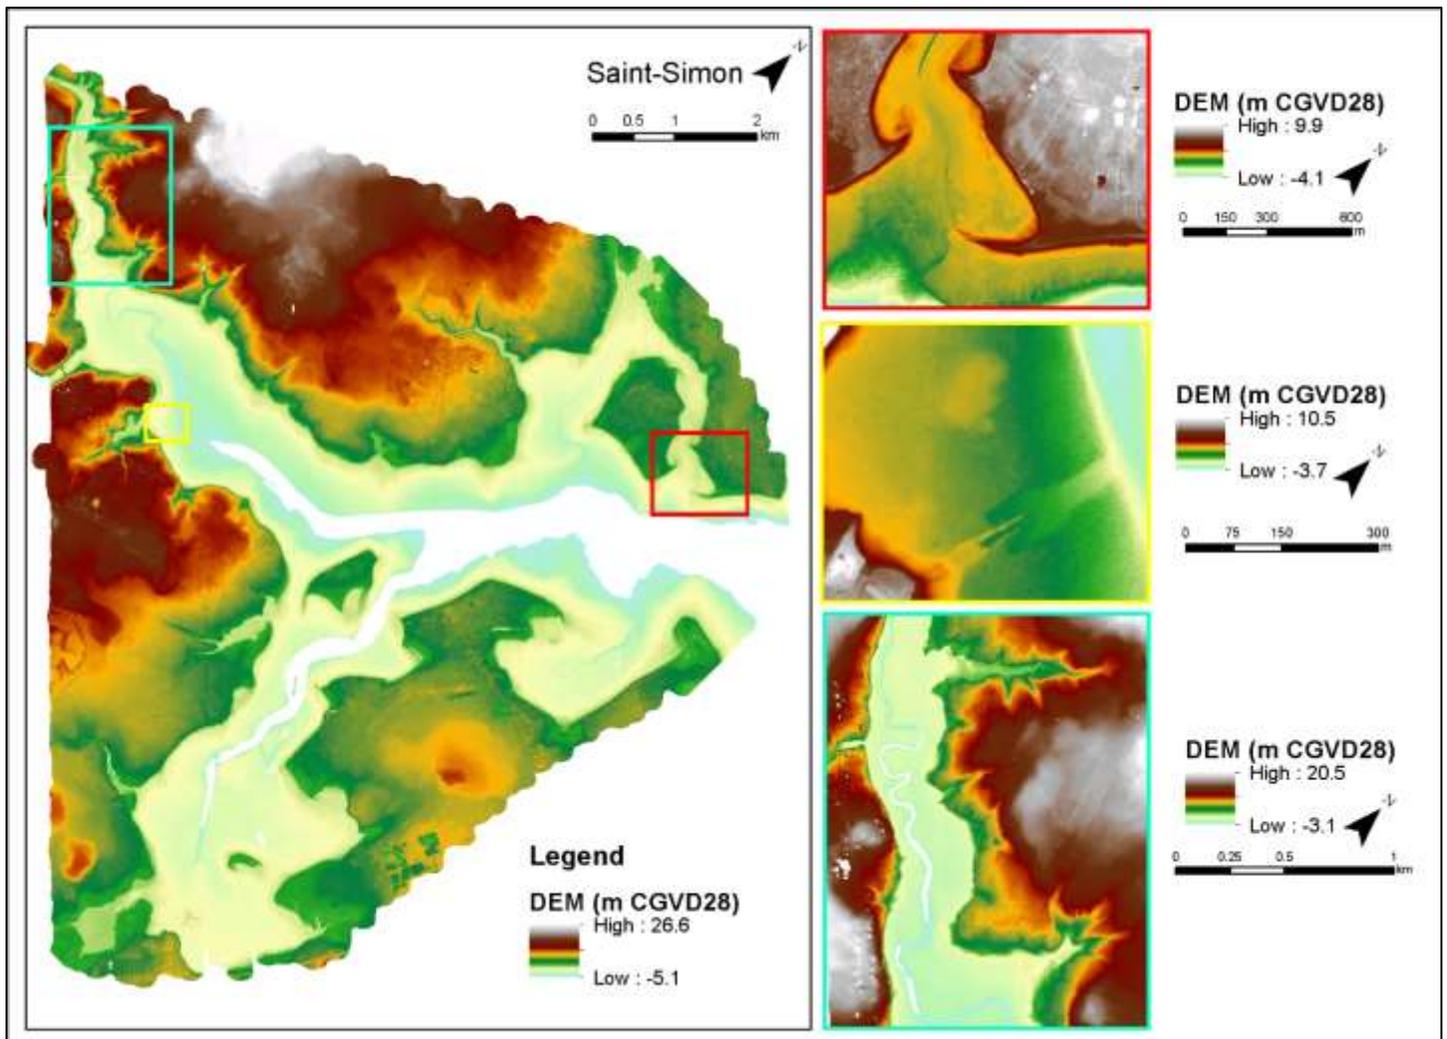
Figure 3.6: Saint Simon Digital Elevation Model for entire study area and insets beside which are matched to the larger figure by border colour.

The Digital Elevation Models for each study area are presented in Figure 3.6 to Figure 3.8. In these figures the minimum and maximum extents of the sub-panels have been adjusted for maximum contrast. Elevation at Saint Simon ranged from 26.6 m elevation on land to a minimum seabed elevation of -5.1 m CGVD28 near the edges of the channel (Figure 3.6). The bathymetric laser did not penetrate the deepest portions of the channel; even the where the river enters the bay in the north (Figure 3.6, aqua sub-panel) we see that the channel is missing. The yellow sub-panel reveals an area that was perhaps dredged to allow boats to access the channel.

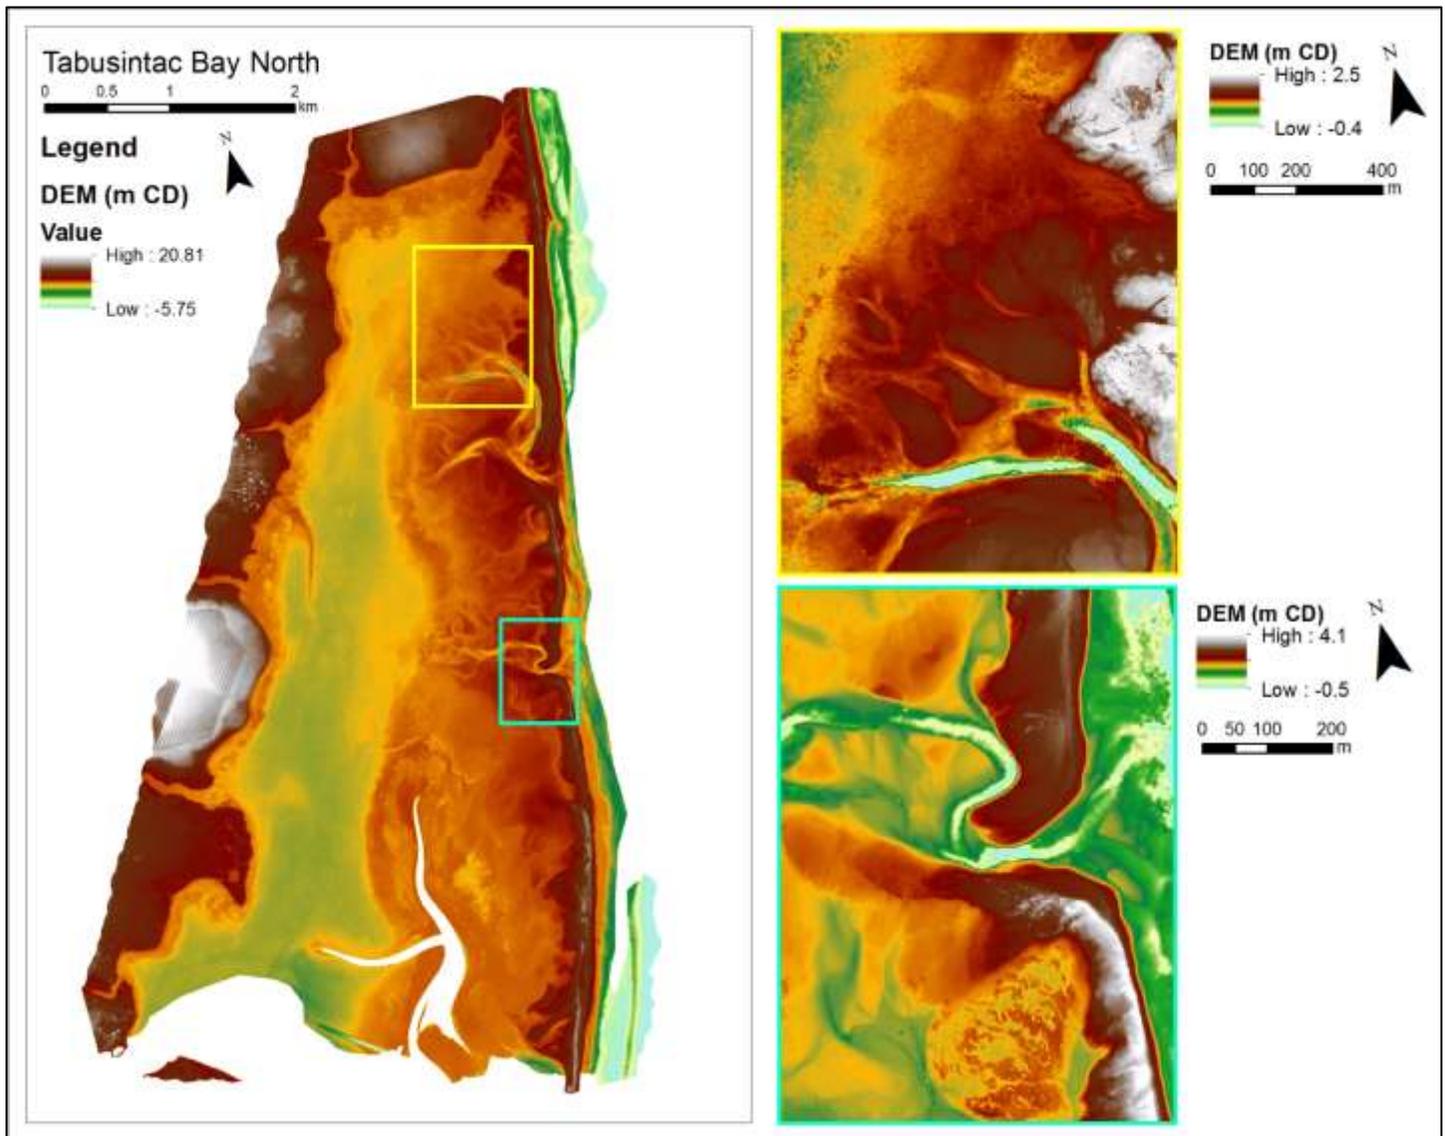
Figure 3.7: Tabusintac Digital Elevation Model for entire study area and insets beside which are matched to the larger figure by border colour. The DEM is a synthesis of the two surveys (Oct. 26 and Nov 10).

At Tabusintac, the DEM is a synthesis of the two surveys (Oct. 26 and Nov 10). Recall that the first survey on Oct. 26 covered the entire study area but suffered from poor water quality, and the second survey on Nov. 10 covered only the western portion of the area of interest with improved water quality. The final blended DEM ranges from 20.81 m CD on land to -5.75 m CD at the southeastern extent of the study area, outside of the bay (Figure 3.7). The main channel that extends from the southern portion of Tabusintac bay was not detected by the lidar, but the remainder of the bay was; depths on the western side ranged from -0.2 to 0.8 m CD, and 0 to 1.5 m CD on the shallow eastern side. Both of the inset panels show much greater detail in the bathymetry near the eastern edge of the bay, where channels cut through the shallow, dynamic seabed.

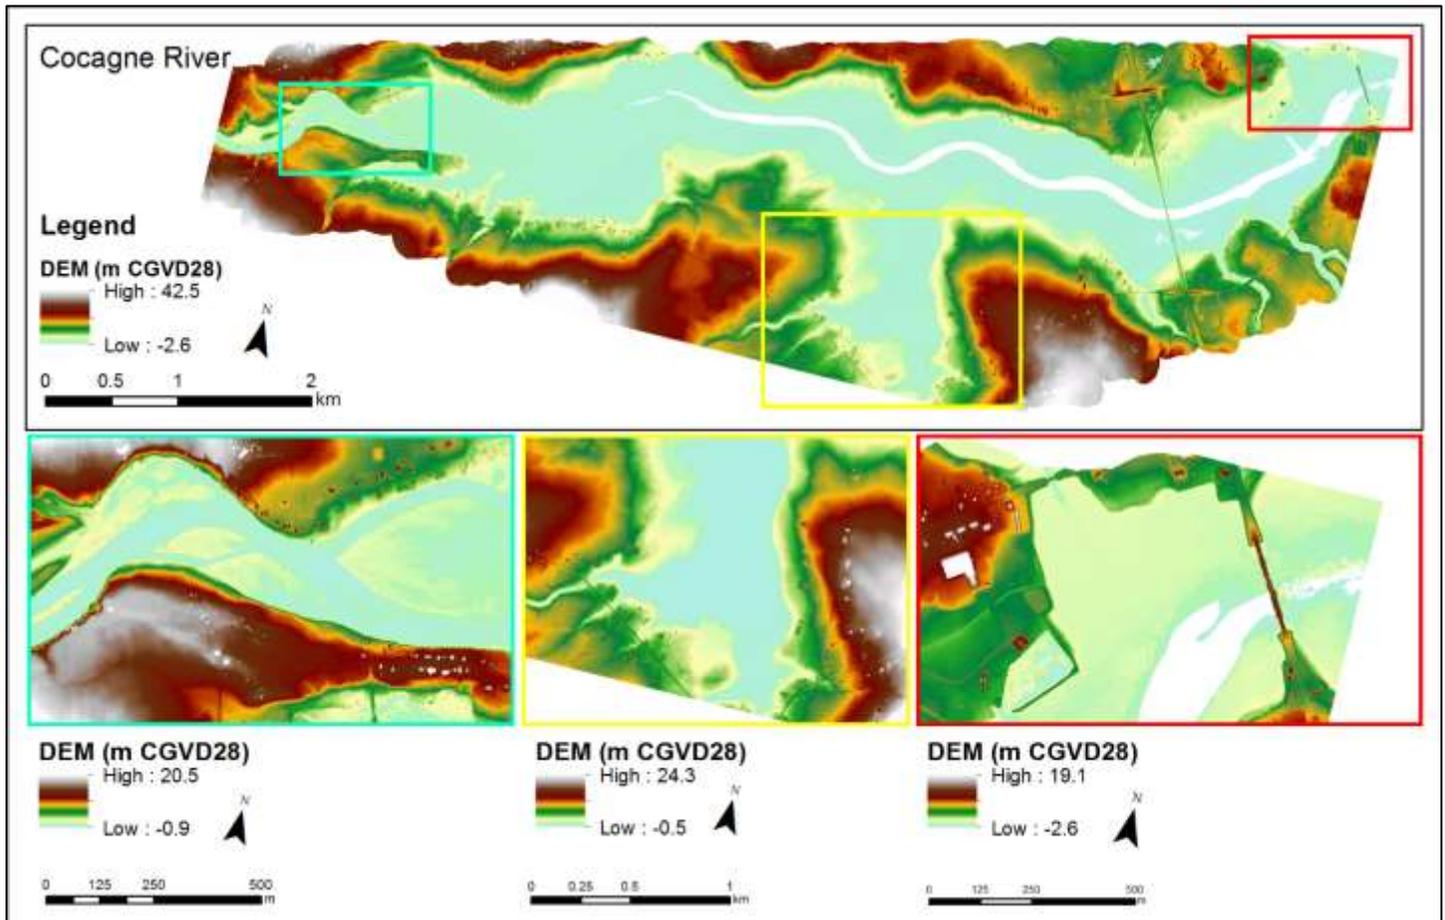
Figure 3.8: Cocagne River Digital Elevation Model for entire study area and insets beside which are matched to the larger figure by border colour.

The Cocagne River DEM ranged from 42.5 m on land to -2.6 m CGVD28 in the water (Figure 3.8). As in the other study sites, the channel was not penetrated by the lidar but coverage elsewhere was excellent, revealing a mostly flat region surrounding the main river channel. The inset panels show river braiding upstream (aqua inset), a shallow bay in the southern region of the study area (yellow inset), and the main highway bridge over the widest portion of the channel (red inset).

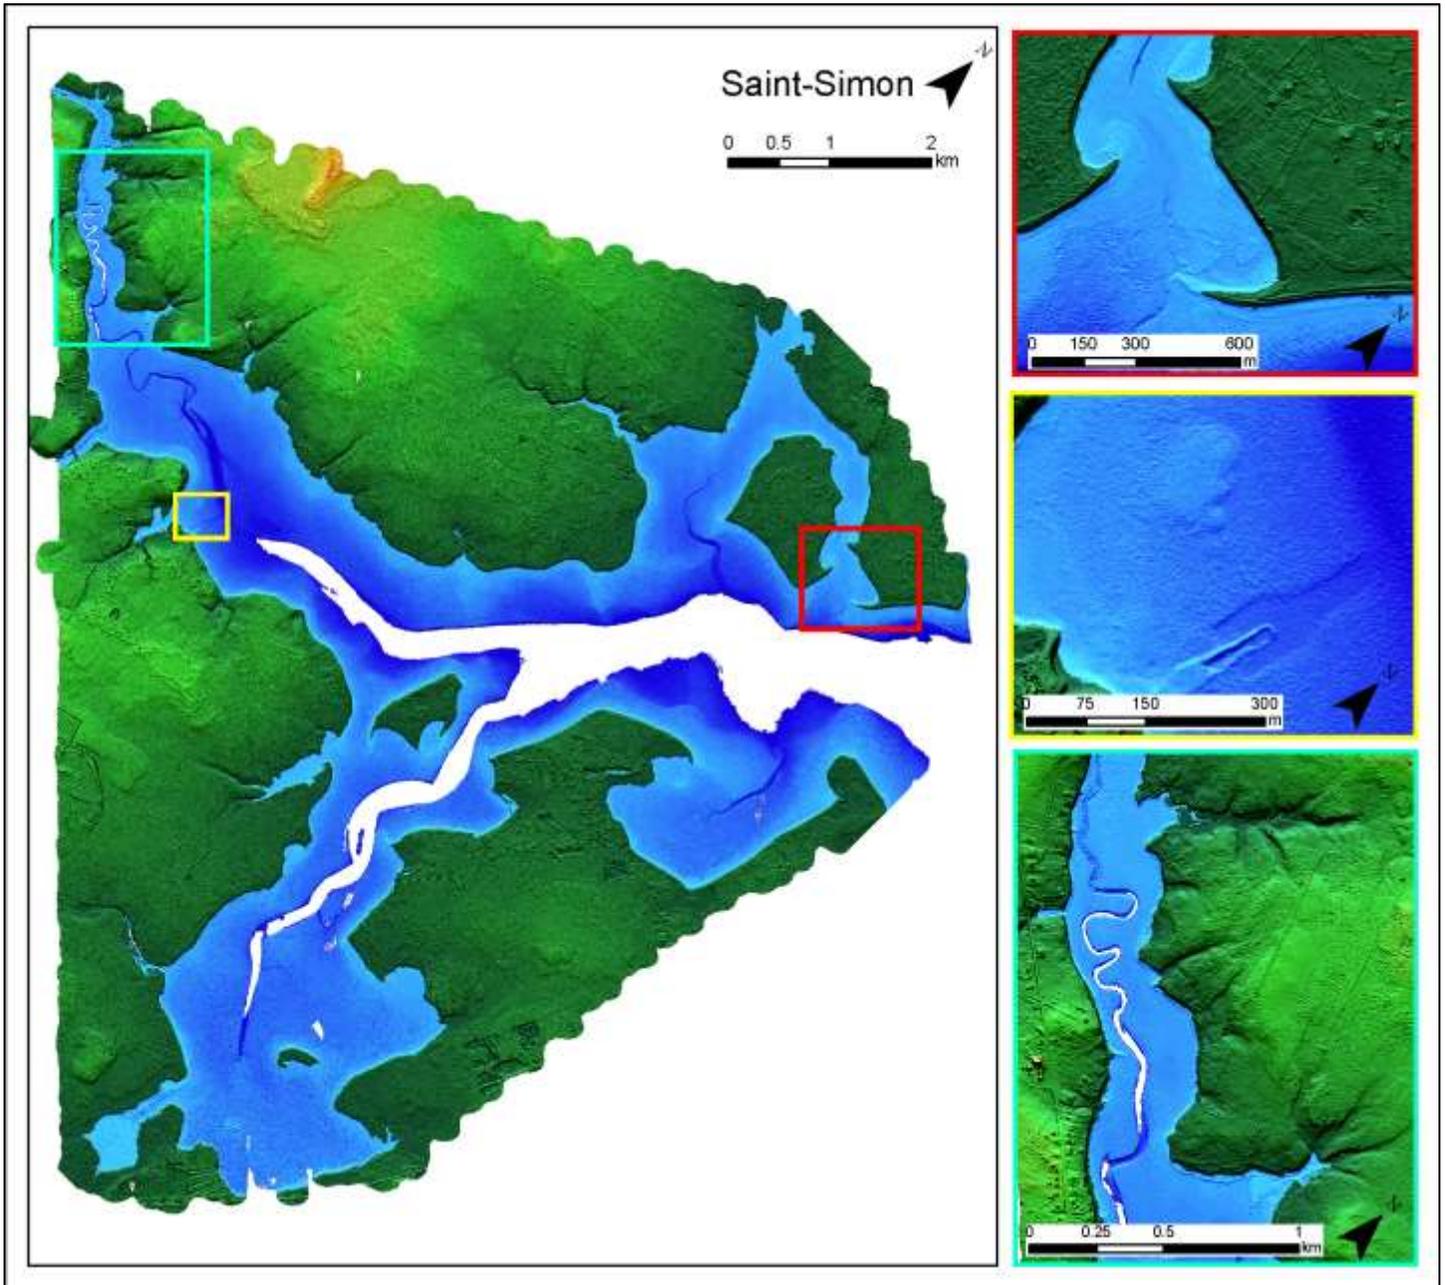
Figure 3.9: Saint-Simon Bay bare-earth Colour Shaded Relief Model showing the whole study area, and insets beside which are matched to the larger figure by border colour.

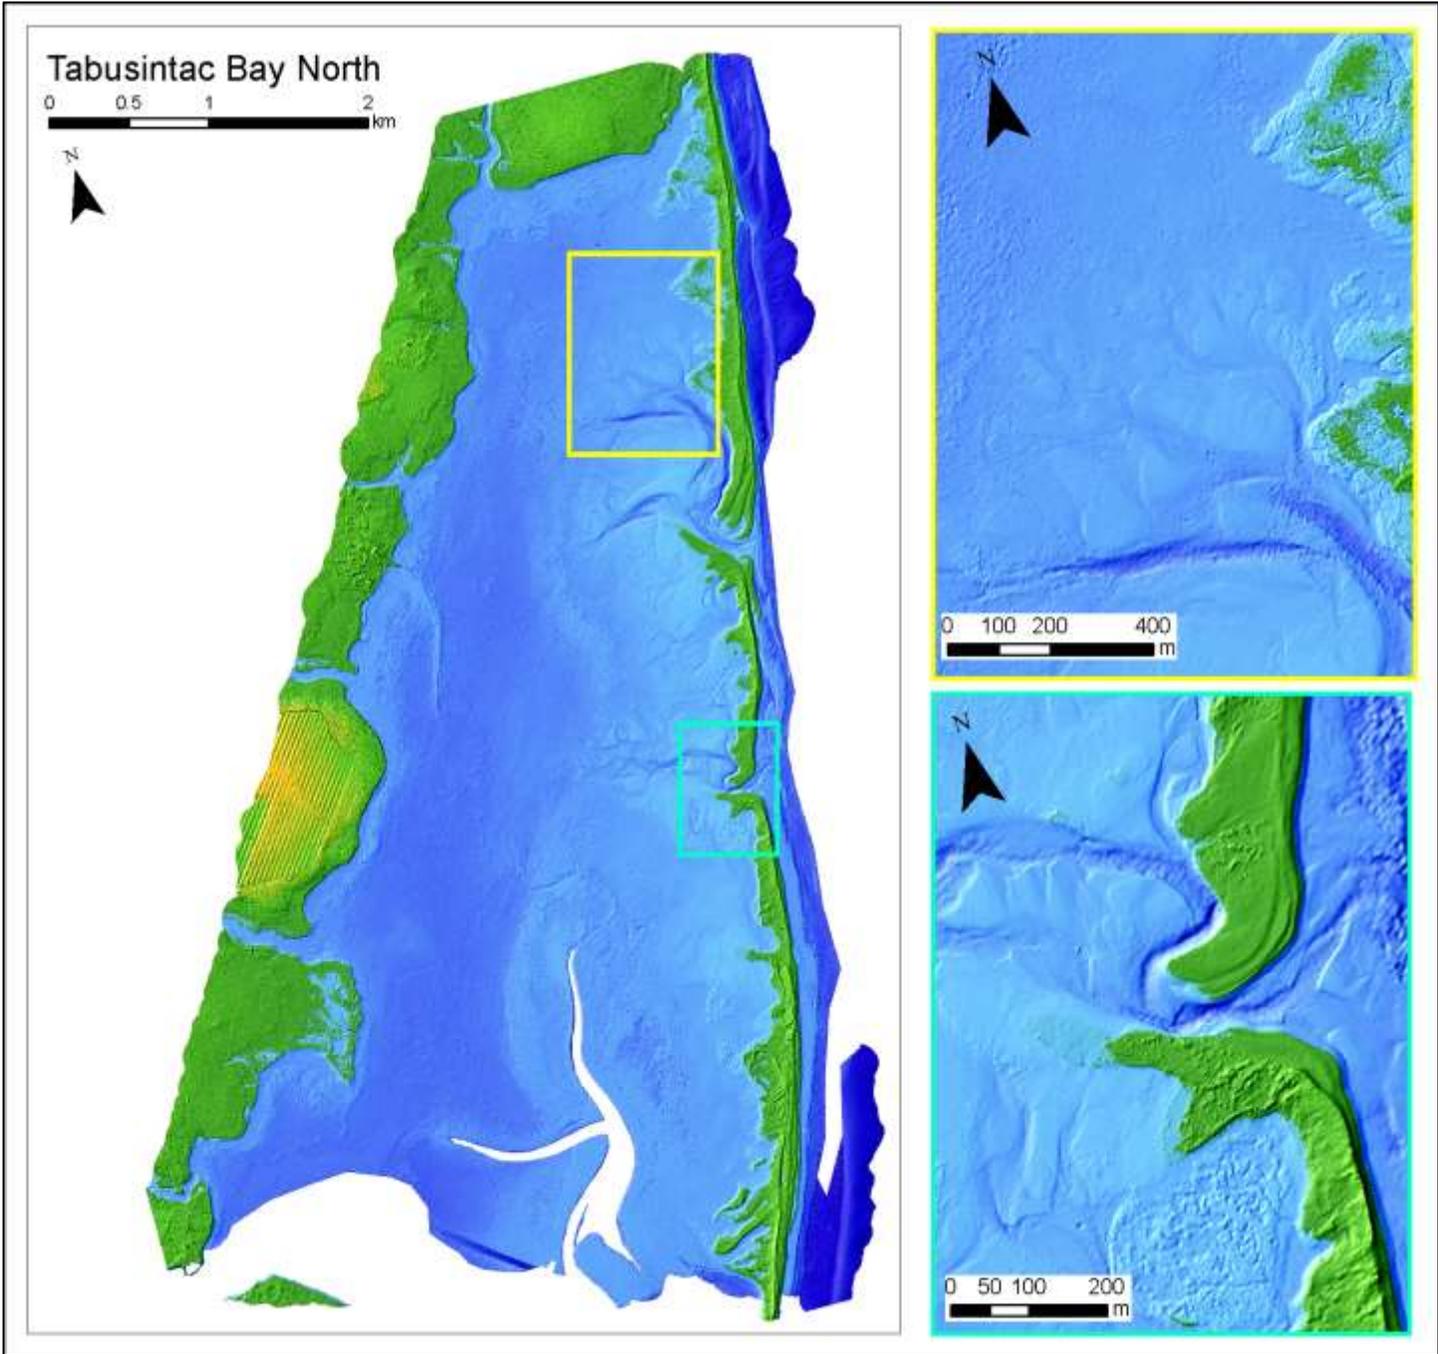
Figure 3.10: Tabusintac Bay bare-earth North Colour Shaded Relief Model showing the whole study area, and insets beside which are matched to the larger figure by border colour.

Topo-Bathymetric Lidar and Photographic Survey of Various Bays located in NB, NS, and PEI inset). The Tabusintac CSR emphasizes the different textures in the seabed, where some areas appear very smooth and others fairly rough (Figure 3.10). The CSR products distinguish land and ocean more clearly than the DEM images, showing the exposed land in the river clearly at Cocagne River (Figure 3.11, aqua inset).

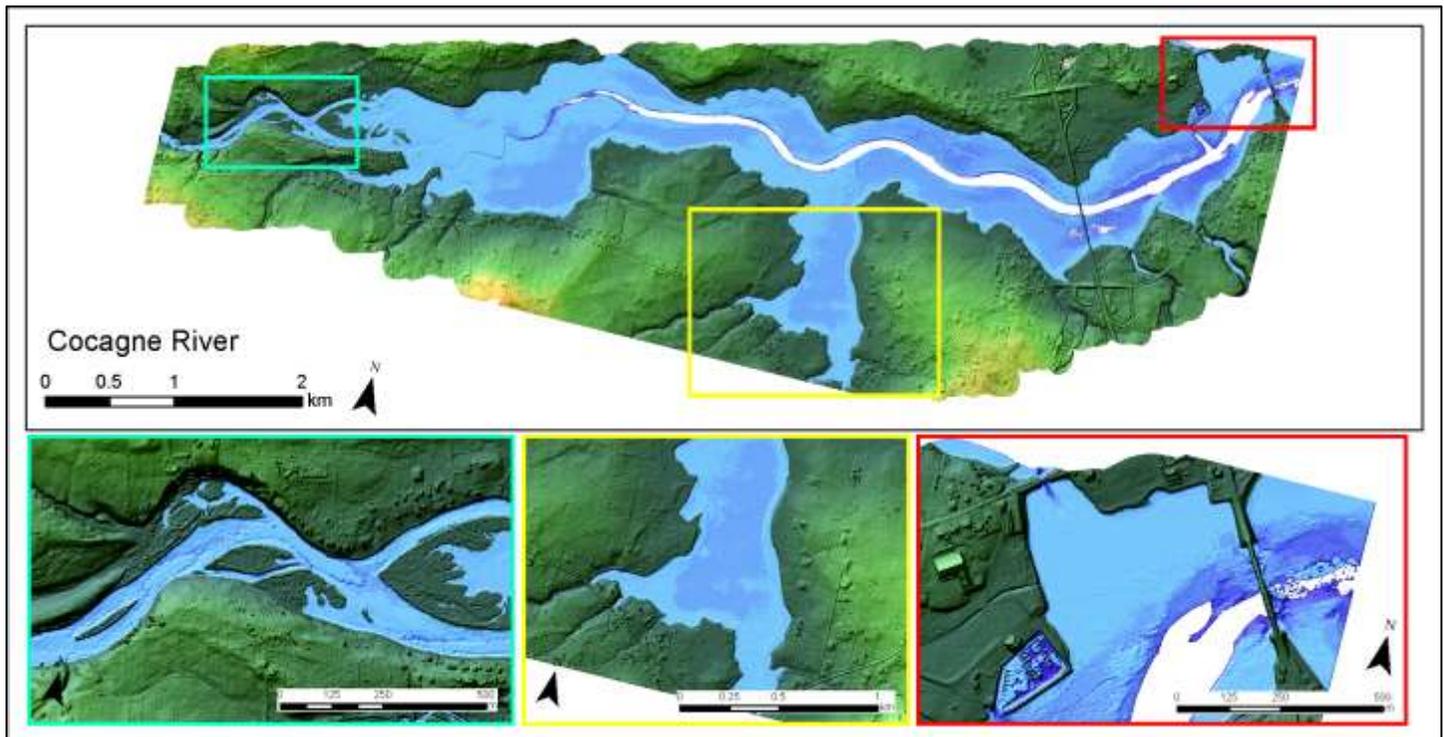
Figure 3.11: Cocagne River bare-earth Colour Shaded Relief Model showing the whole study area, and insets below which are matched to the larger figure by border colour.

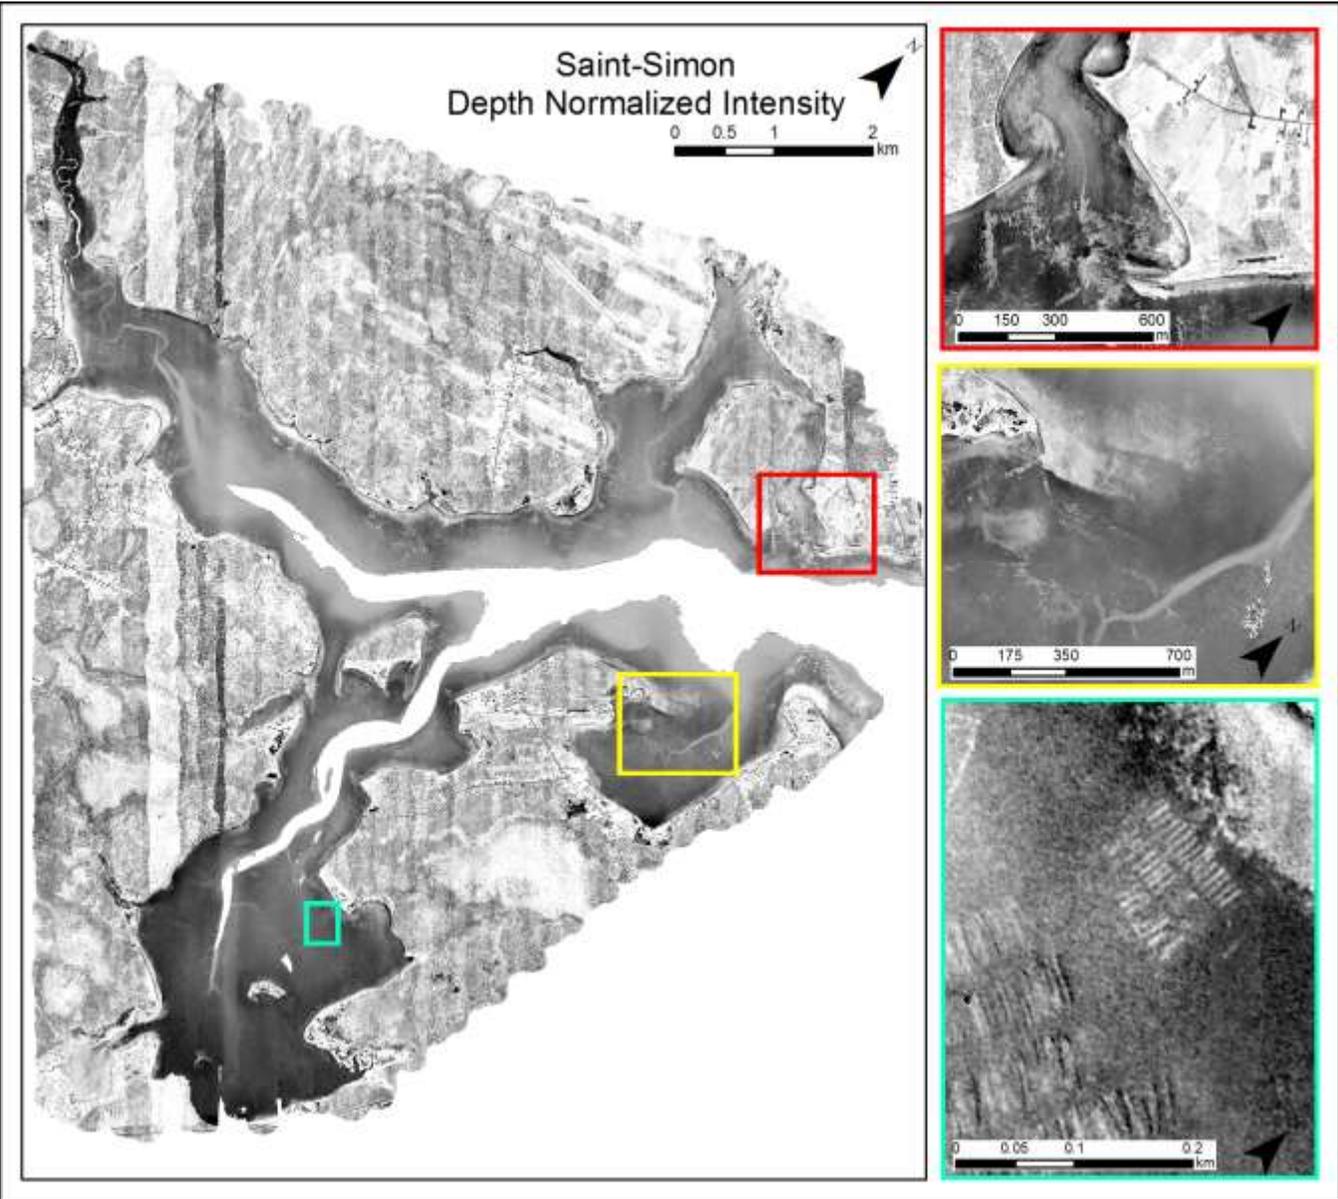
Figure 3.12: Depth normalized intensity/amplitude for Saint-Simon, Oct. 24. The insets on the right correspond to boxes of matching colour on the large map. The red and yellow insets highlight the different intensity signal for submerged eelgrass and sand, while the aqua inset shows floating (on the left) and submerged (on the right) aquaculture cages (the orthophoto for this panel is shown in Figure 3.15).

The depth normalized intensity models (DNIs) can be a powerful tool to reveal submerged features and bottom type information that the air photos and DEM may not show. The amplitude data also show a great deal of contrast between brightly coloured seabed and the dark colour of eelgrass. At Saint-Simon, this contrast is shown clearly in the red and yellow insets (Figure 3.12), while the aqua-coloured inset shows floating aquaculture cages on the left of the image, and submerged cages on the right. The intensity signal is slightly different for the floating and submerged cages, but the air photos confirm which are floating and which are submerged in Figure 3.15. In other cases, the submerged cages are not visible at all in the air photos, but can be identified using the DNI image. At Tabusintac and Cocagne River, vegetation and interesting bottom features are revealed in the intensity data (Figure 3.13 and Figure 3.14, respectively).

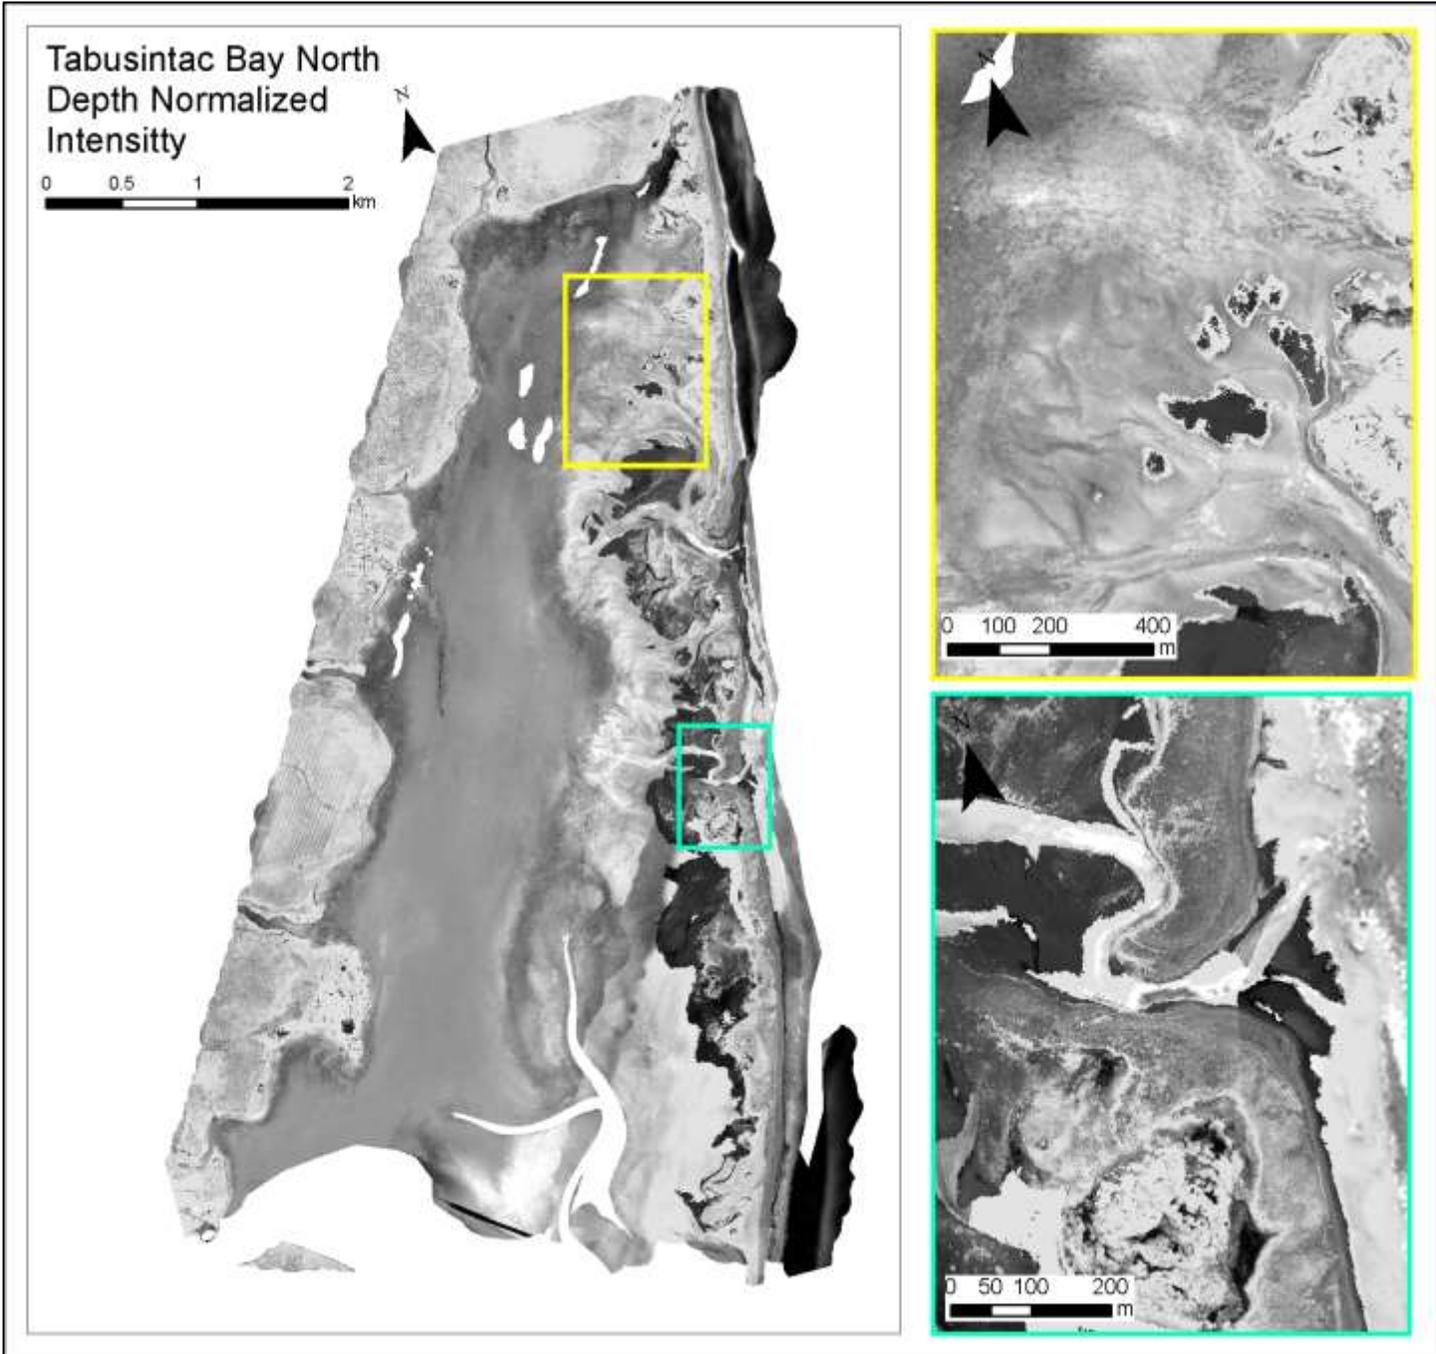
Figure 3.13: Depth normalized intensity/amplitude for Tabusintac. The insets on the right correspond to boxes of matching colour on the large map. The DNI is a synthesis of the two surveys (Oct. 26 and Nov 10).

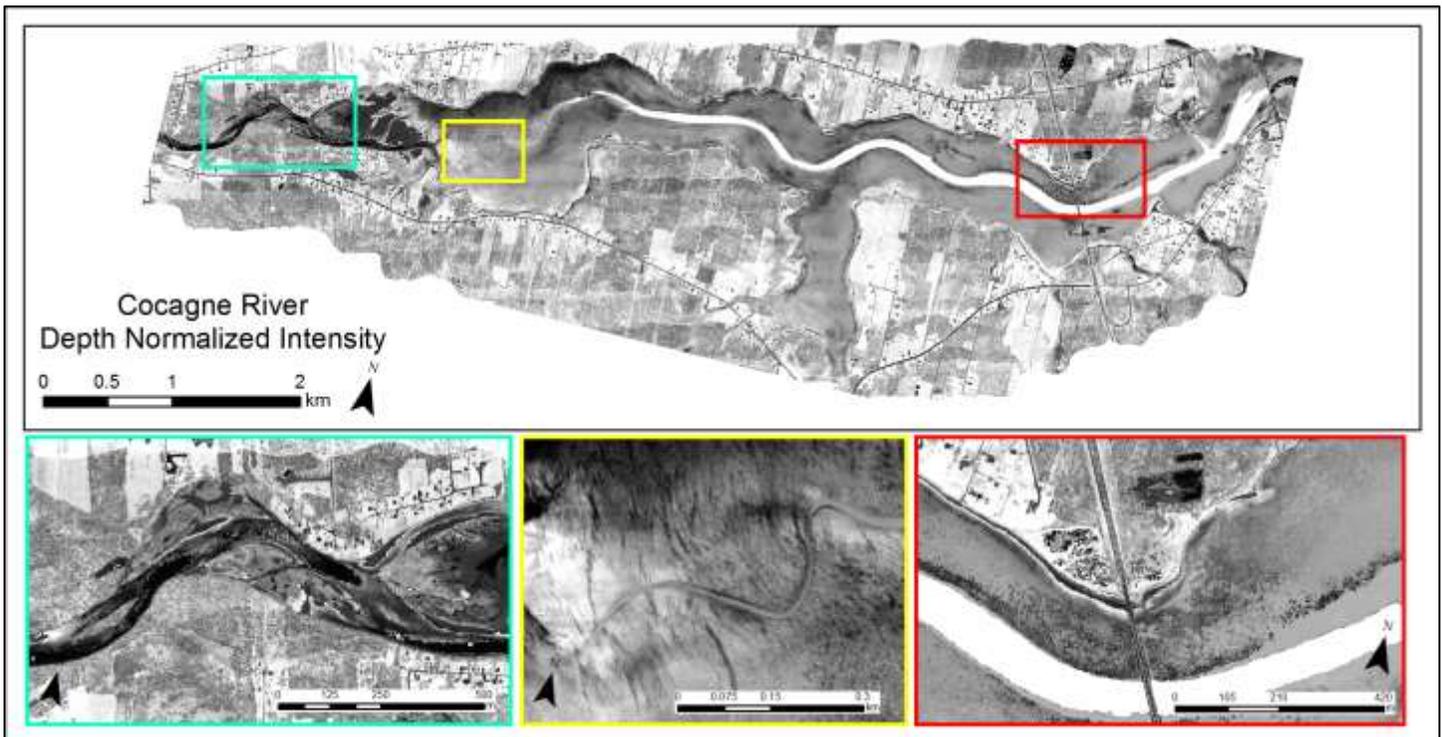
Figure 3.14: Depth normalized intensity/amplitude for Cocagne, Oct. 22. The insets on the bottom correspond to boxes of matching colour on the large map.

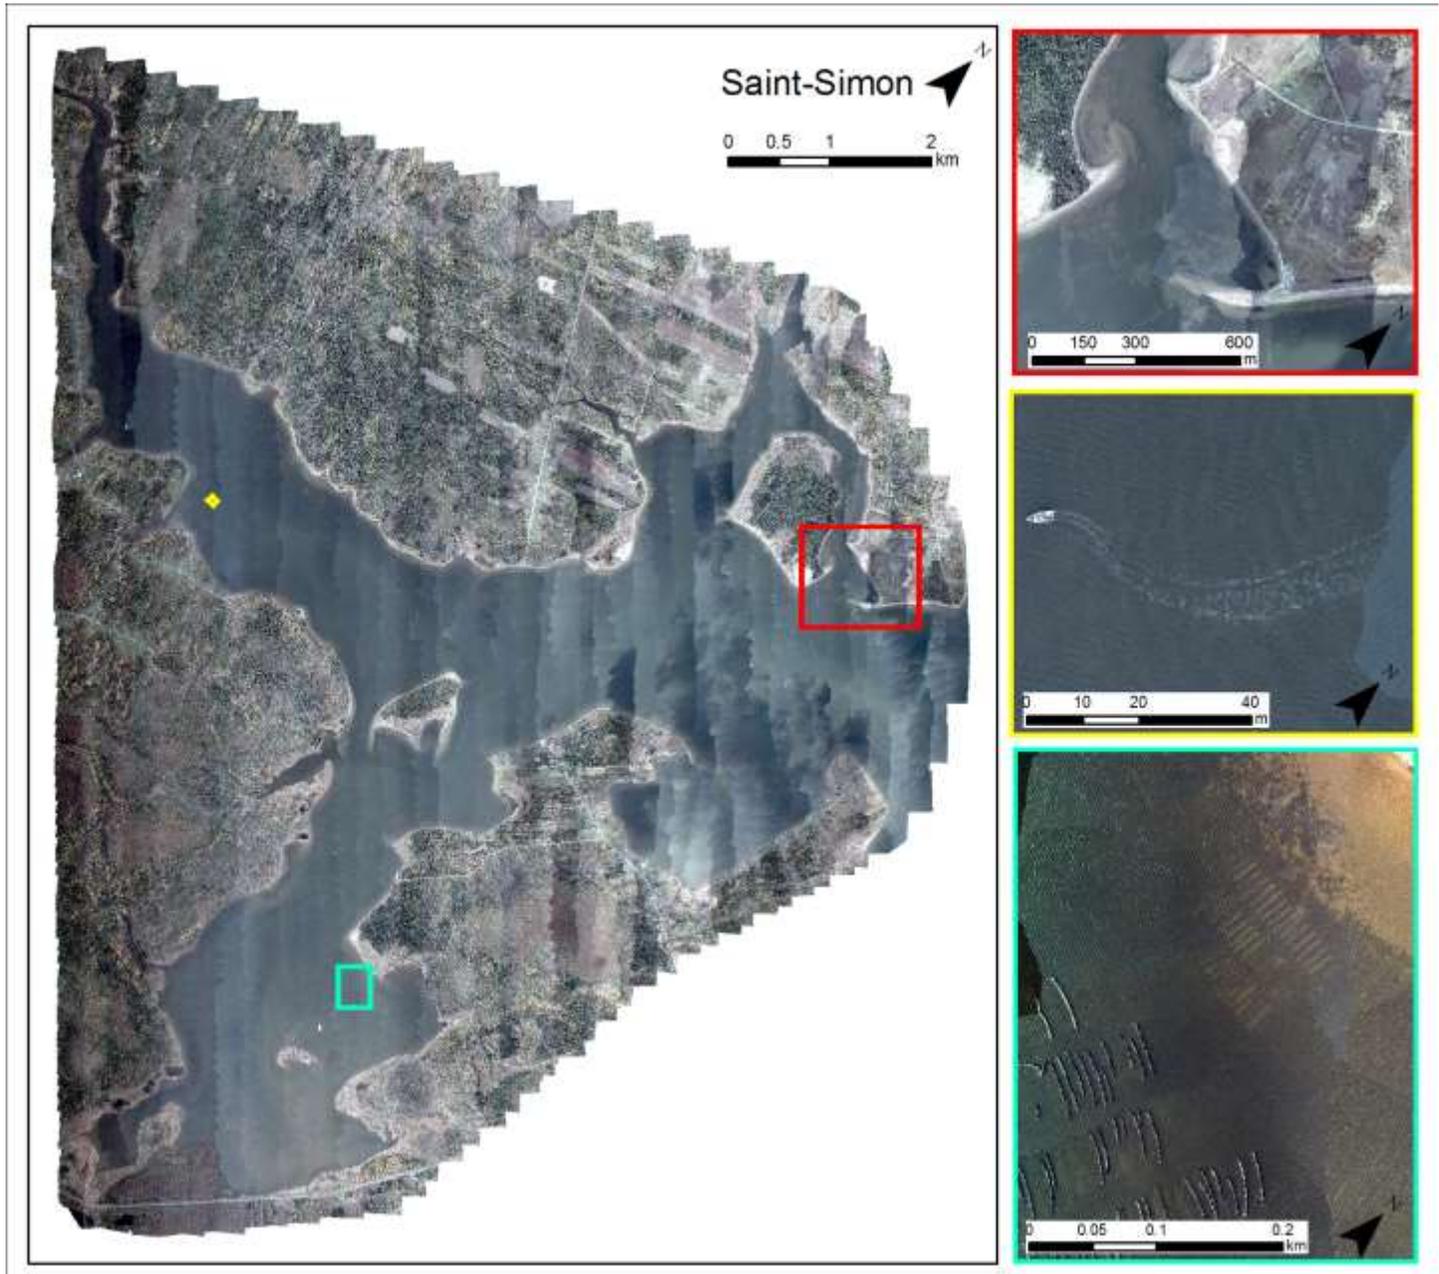
Figure 3.15: Saint-Simon Bay Orthophoto Mosaic from Oct. 24, 2015 showing the whole study area, and insets beside which are matched to the larger figure by border colour. The insets, from top to bottom, highlight submerged vegetation, the AGRG boat conducting ground truth surveys during the survey, and aquaculture, both submerged and floating, in the southern part of the bay (same extent as Figure 3.12).

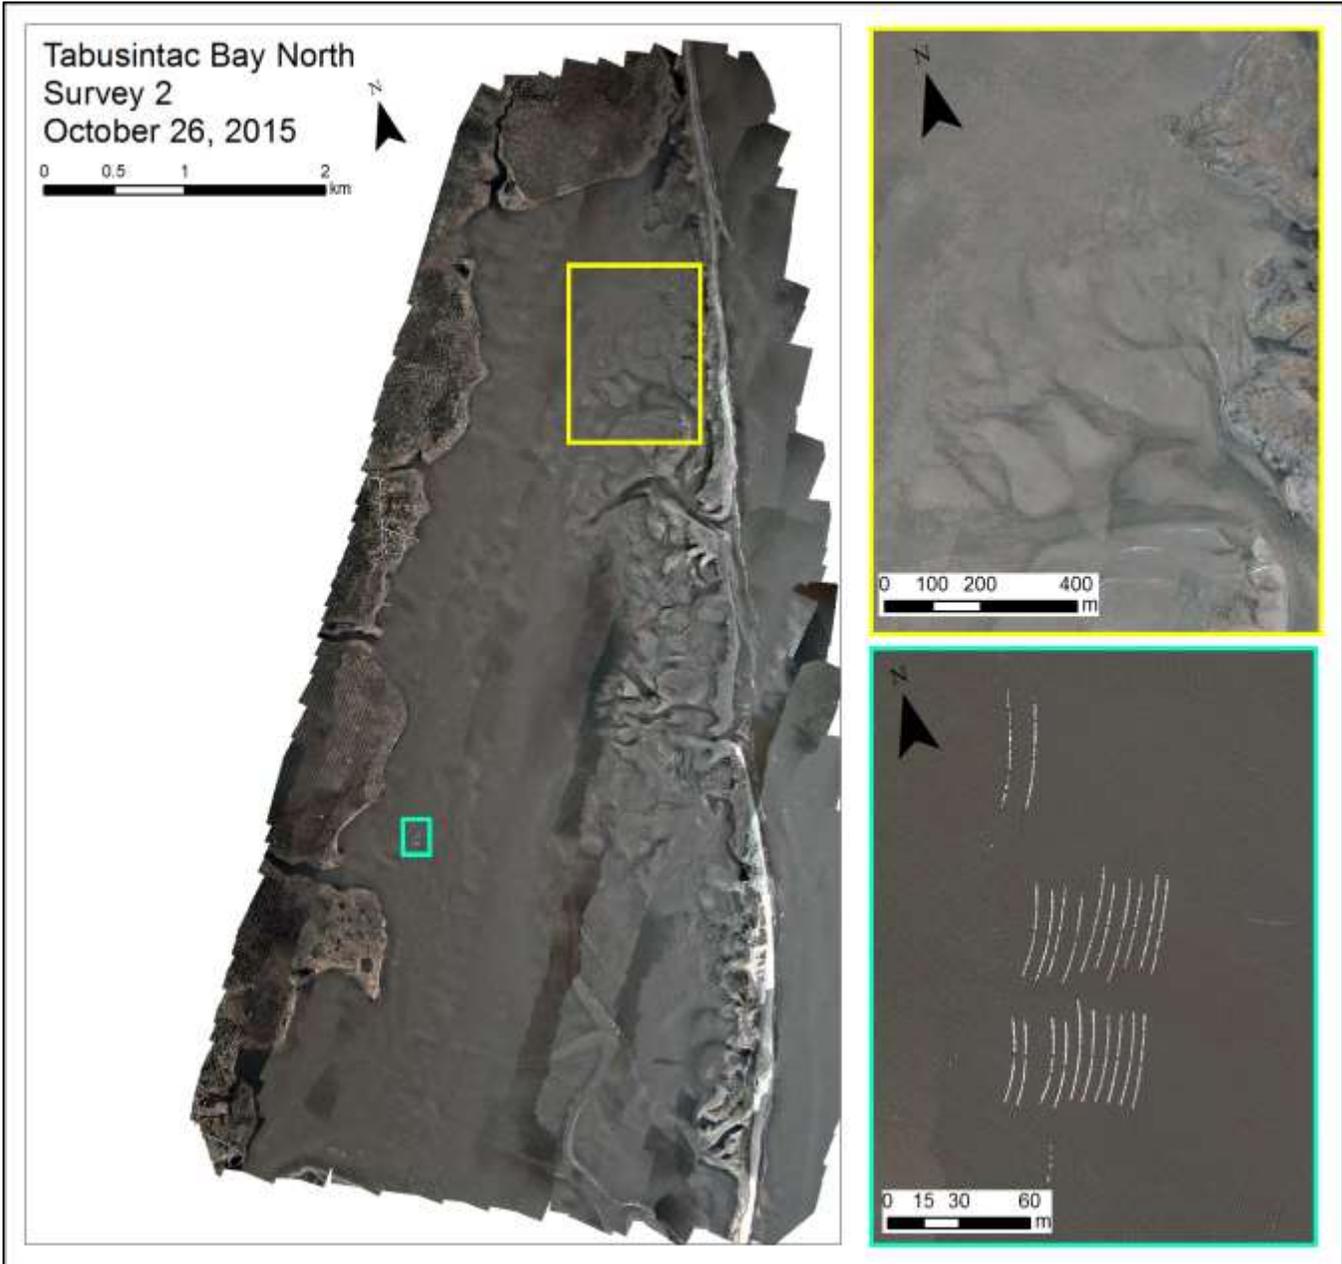
Figure 3.16: Tabusintac Bay North Oct. 26 Orthophoto Mosaic showing the whole study area, and insets beside which are matched to the larger figure by border colour.
