Topo-Bathymetric Lidar and Photographic Survey of Various Bays located in New Brunswick, Nova Scotia and Prince Edward Island

Kate Collins, Tim Webster, PhD, Nathan
Crowell, Kevin McGuigan, Candace
MacDonald
Applied Geomatics Research Group
NSCC, Middleton
Tel. 902 825 5475
email: tim.webster@nsc.ca

March 30, 2016

Topo-Bathymetric Lidar and Photographic Survey of Various Bays located in NB, NS, and PEI

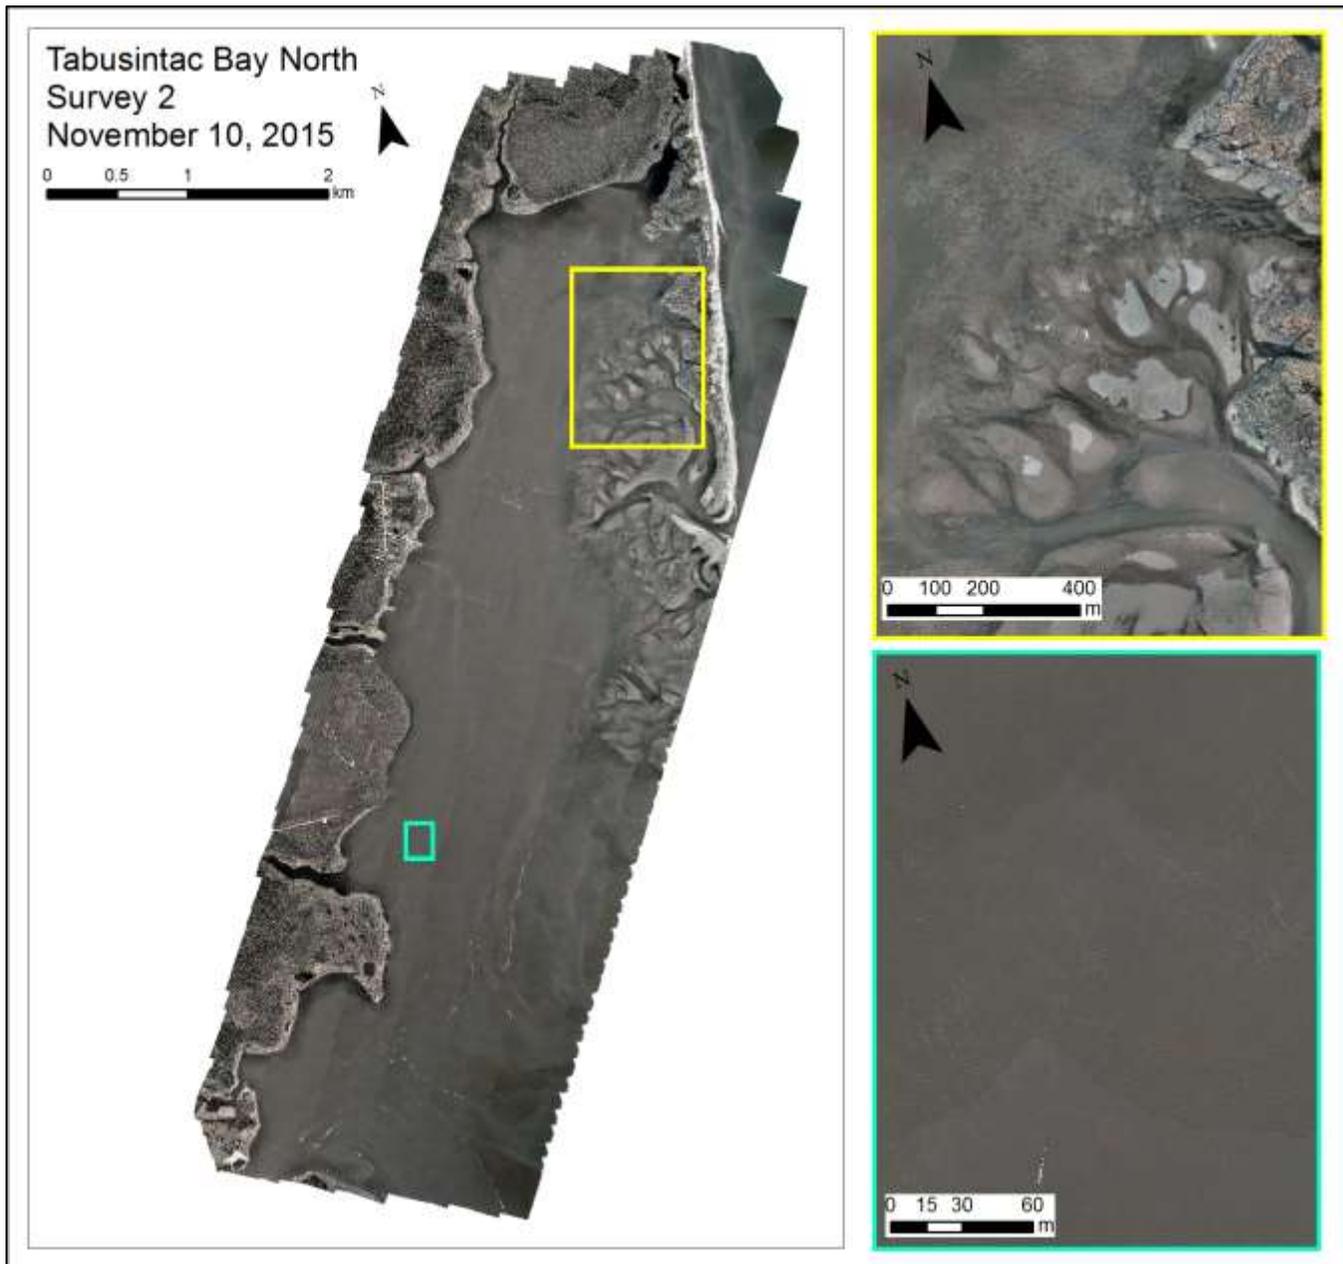
Figure 3.17: Tabusintac Bay North Nov. 10 Orthophoto Mosaic showing the whole study area, and insets beside which are matched to the larger figure by border colour. Note the absence of the aquaculture that was visible in Figure 3.16.

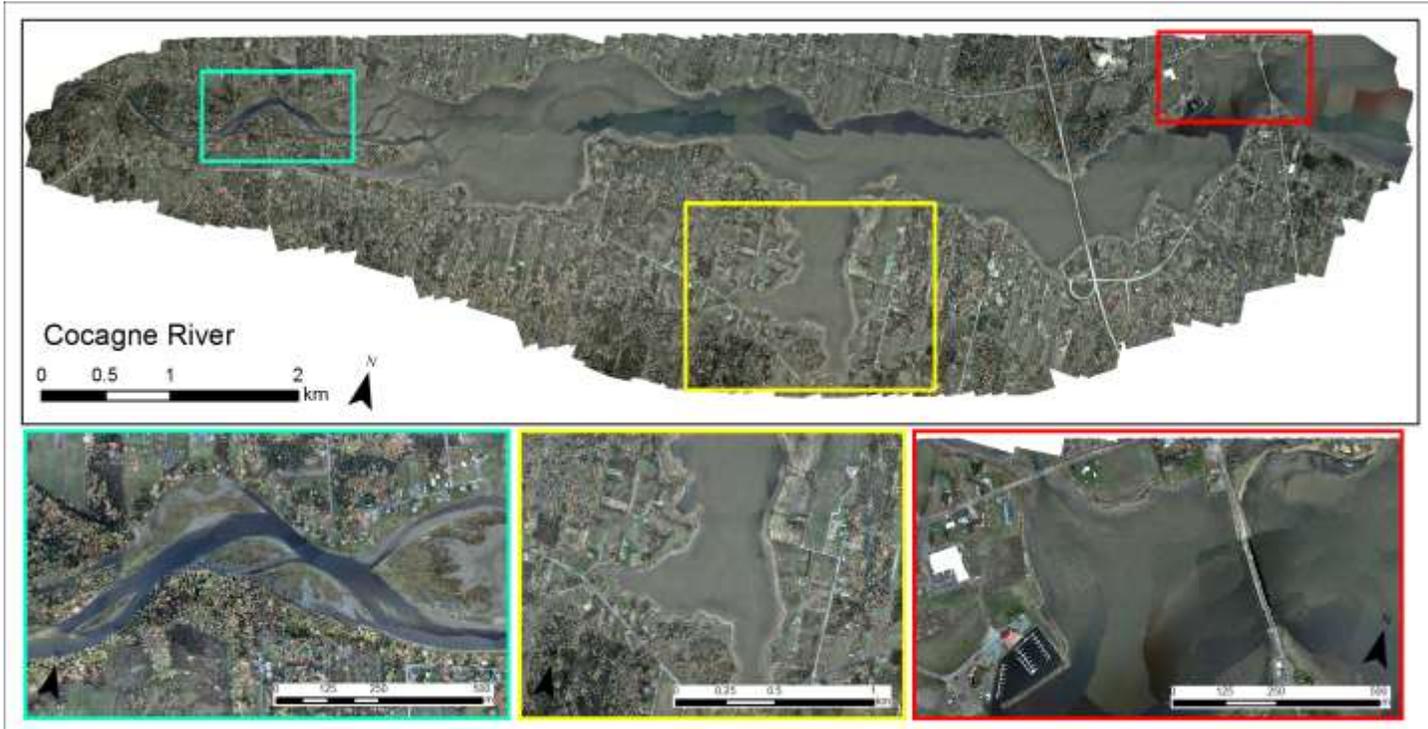
Figure 3.18: Cocagne River True Colour Composite Orthophoto Mosaic showing the whole study area, and insets below which are matched to the larger figure by border colour.

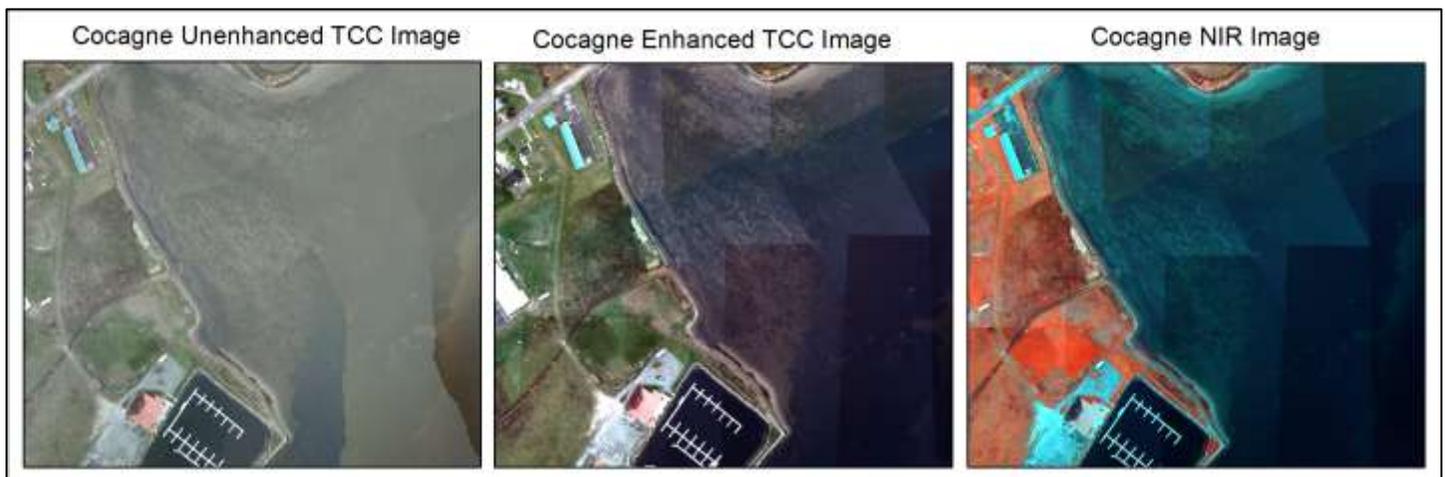
Figure 3.19: Photo products at Cocagne River showing the unenhanced orthophoto mosaic on the left, the enhanced true colour composite in the middle, and the near infrared image on the right. Note how the enhanced images (TCC and NIR) both show the submerged vegetation in much greater contrast and detail than the unenhanced photo.

For data delivery the original 16-bit photos were converted to 8-bit, with four bands (red, green, blue, and near infrared). True Colour Composite (TCC) images and Near Infrared (NIR) images were also produced. The TCC images are composed of the red, green and blue bands saved in a JPEG 2000 format, and the NIR images are a composition of the near infrared, green and blue bands, and saved in a JPEG 2000 format. An example of the differences between these images and the typical 5 cm orthophoto at Cocagne shows how the enhanced images (TCC and NIR) provide more contrast and detail than the unenhanced orthophoto (Figure 3.19).

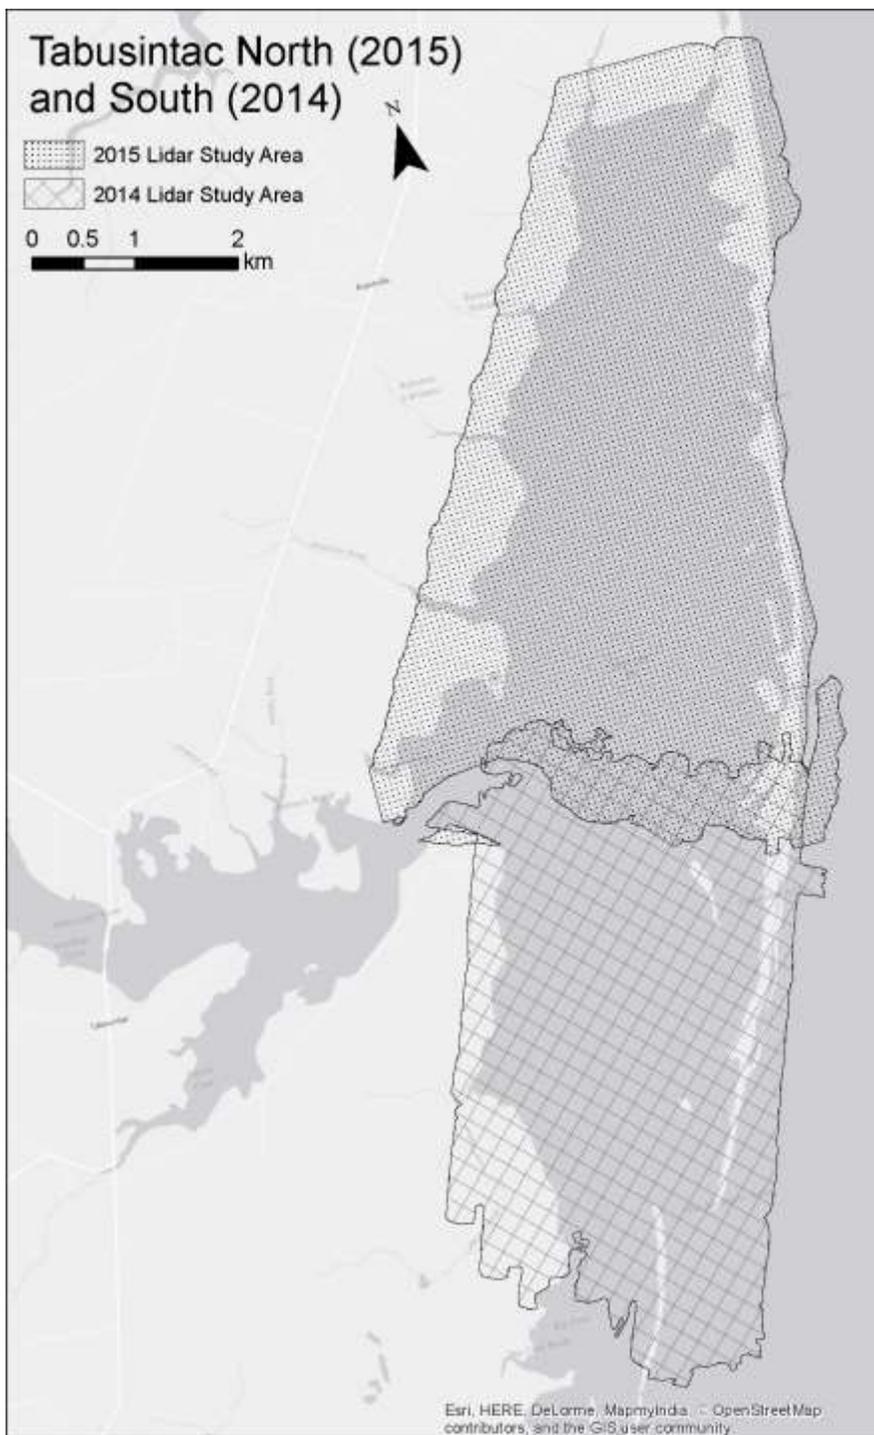
Figure 4.1: Study areas for Tabusintac North, which was surveyed in 2015 for this project, and Tabusintac South, which was surveyed in 2014 for a PWGSC project.

The 2014 and 2015 study areas for Tabusintac and Cocagne are shown in Figure 4.1 and Figure 4.2, respectively, and the DEMs for both years are shown in Figure 4.3 and Figure 4.4.

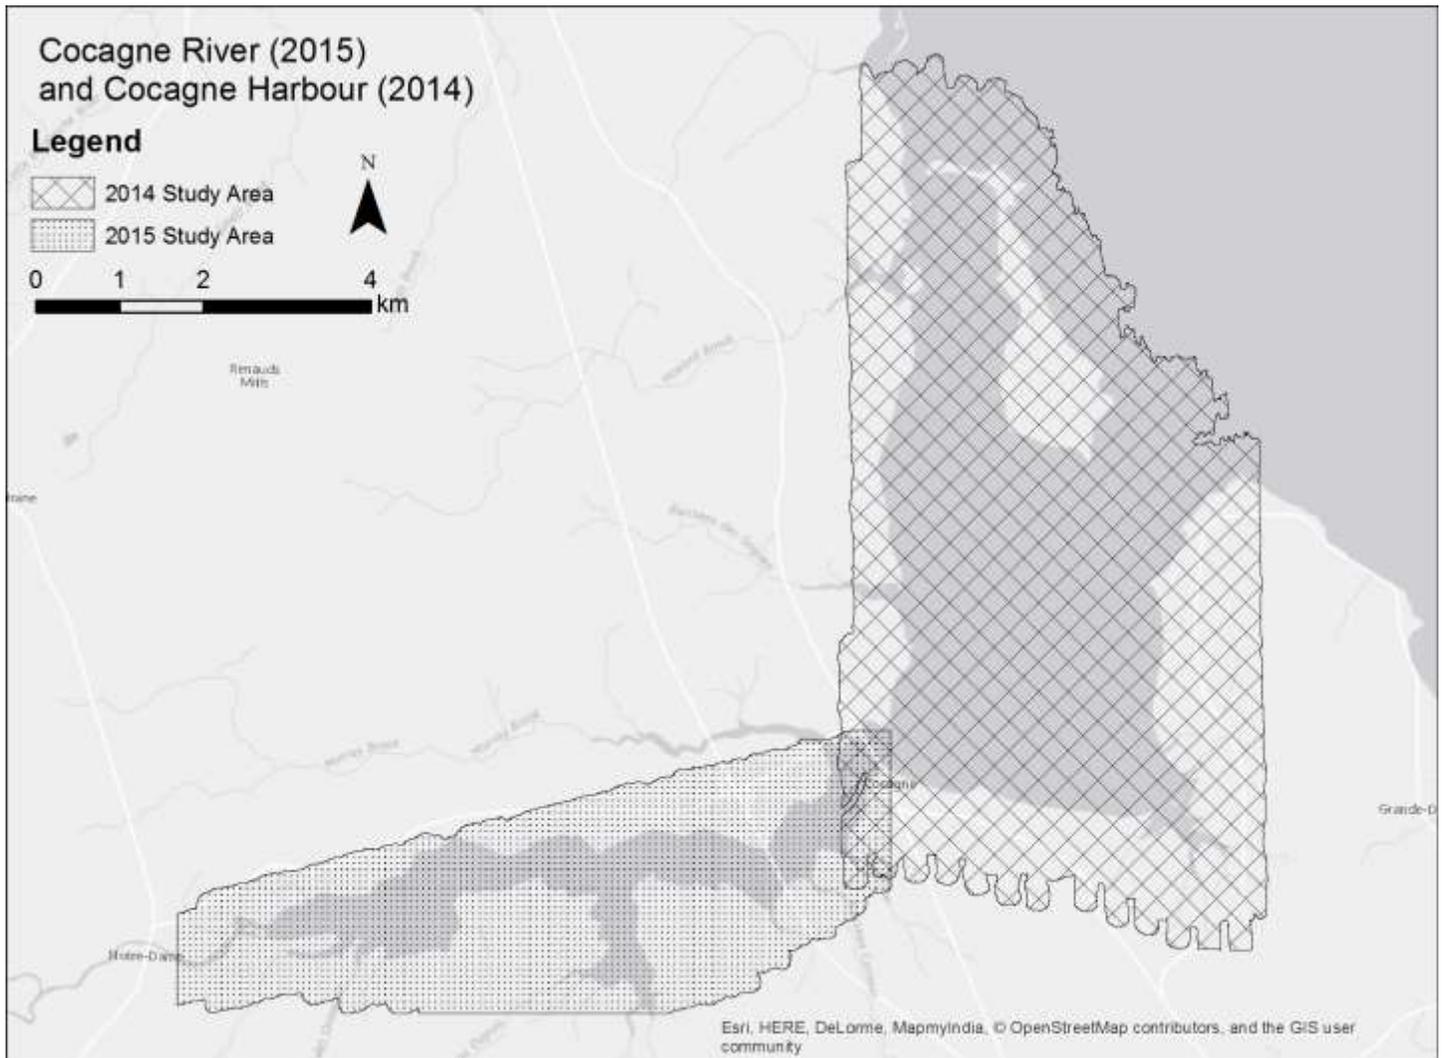
Figure 4.2: Study areas for Cocagne River, which was surveyed in 2015 for this project, and Cocagne Harbour, which was surveyed in 2014, also for DFO Gulf Region.

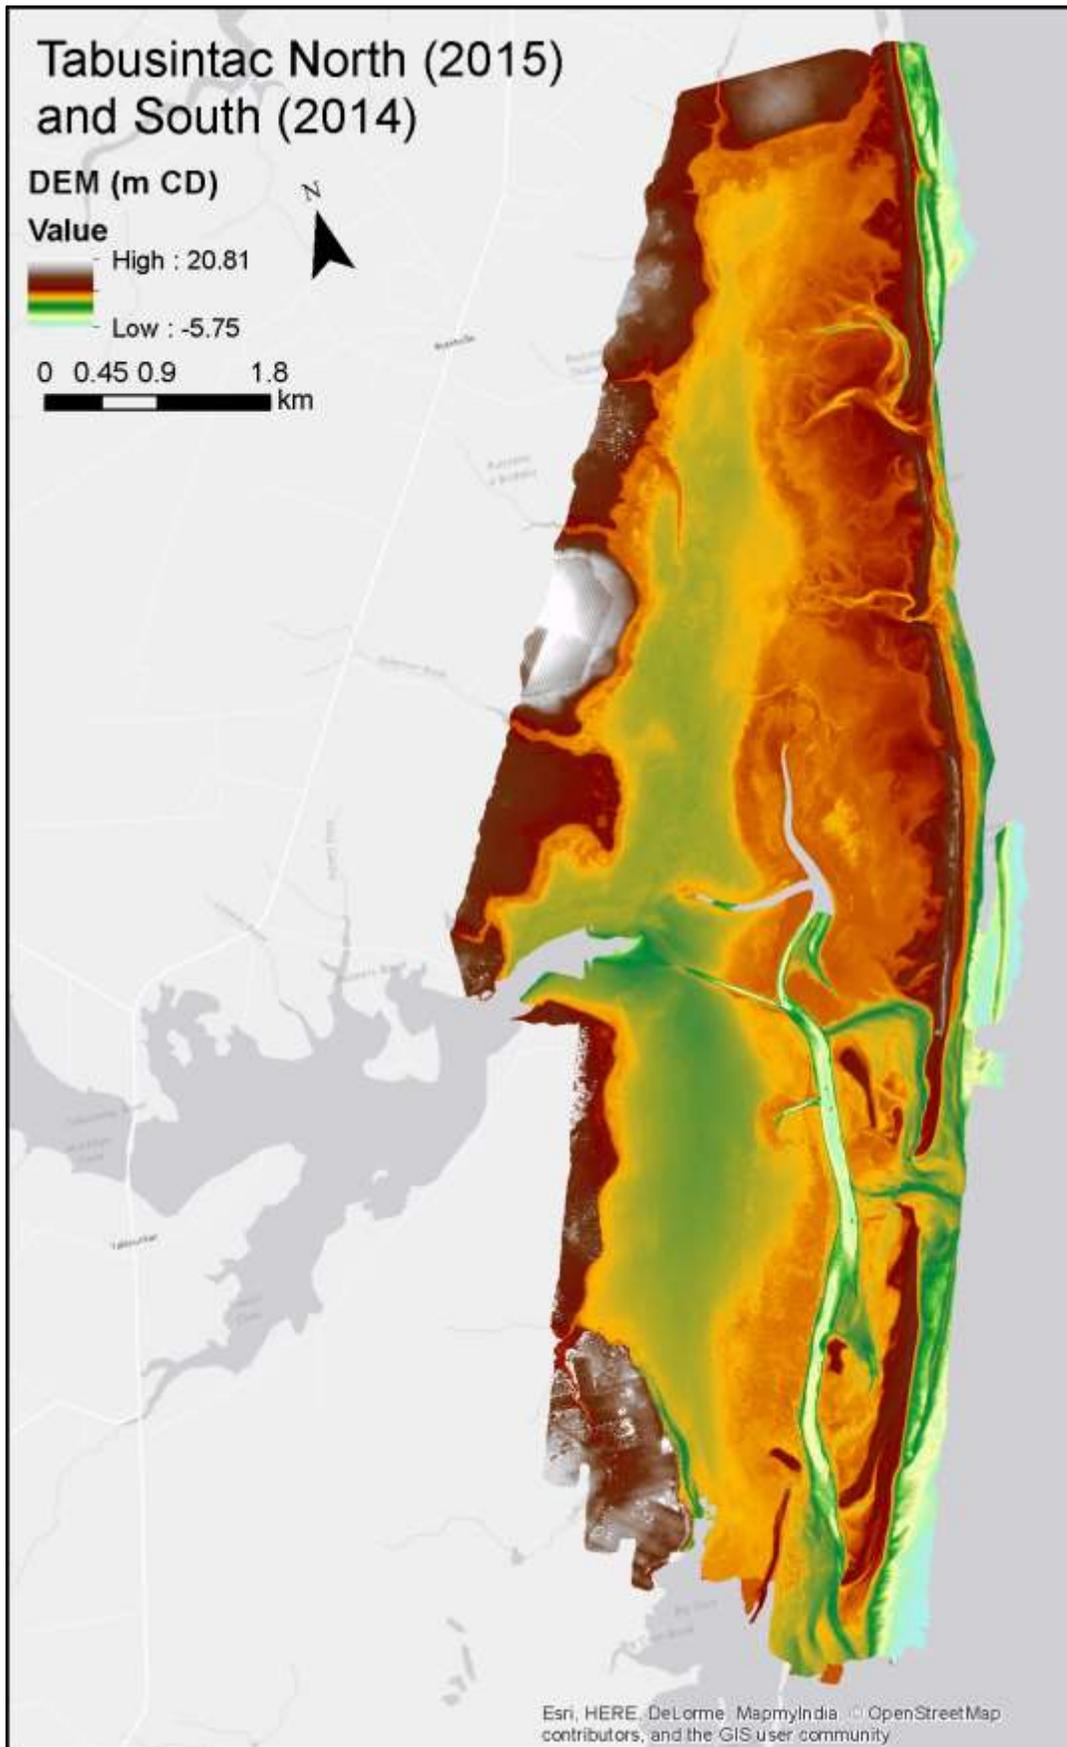
Figure 4.3: Tabusintac North, which was surveyed in 2015 for this project, and Tabusintac South, which was surveyed in 2014 for a PWGSC project.

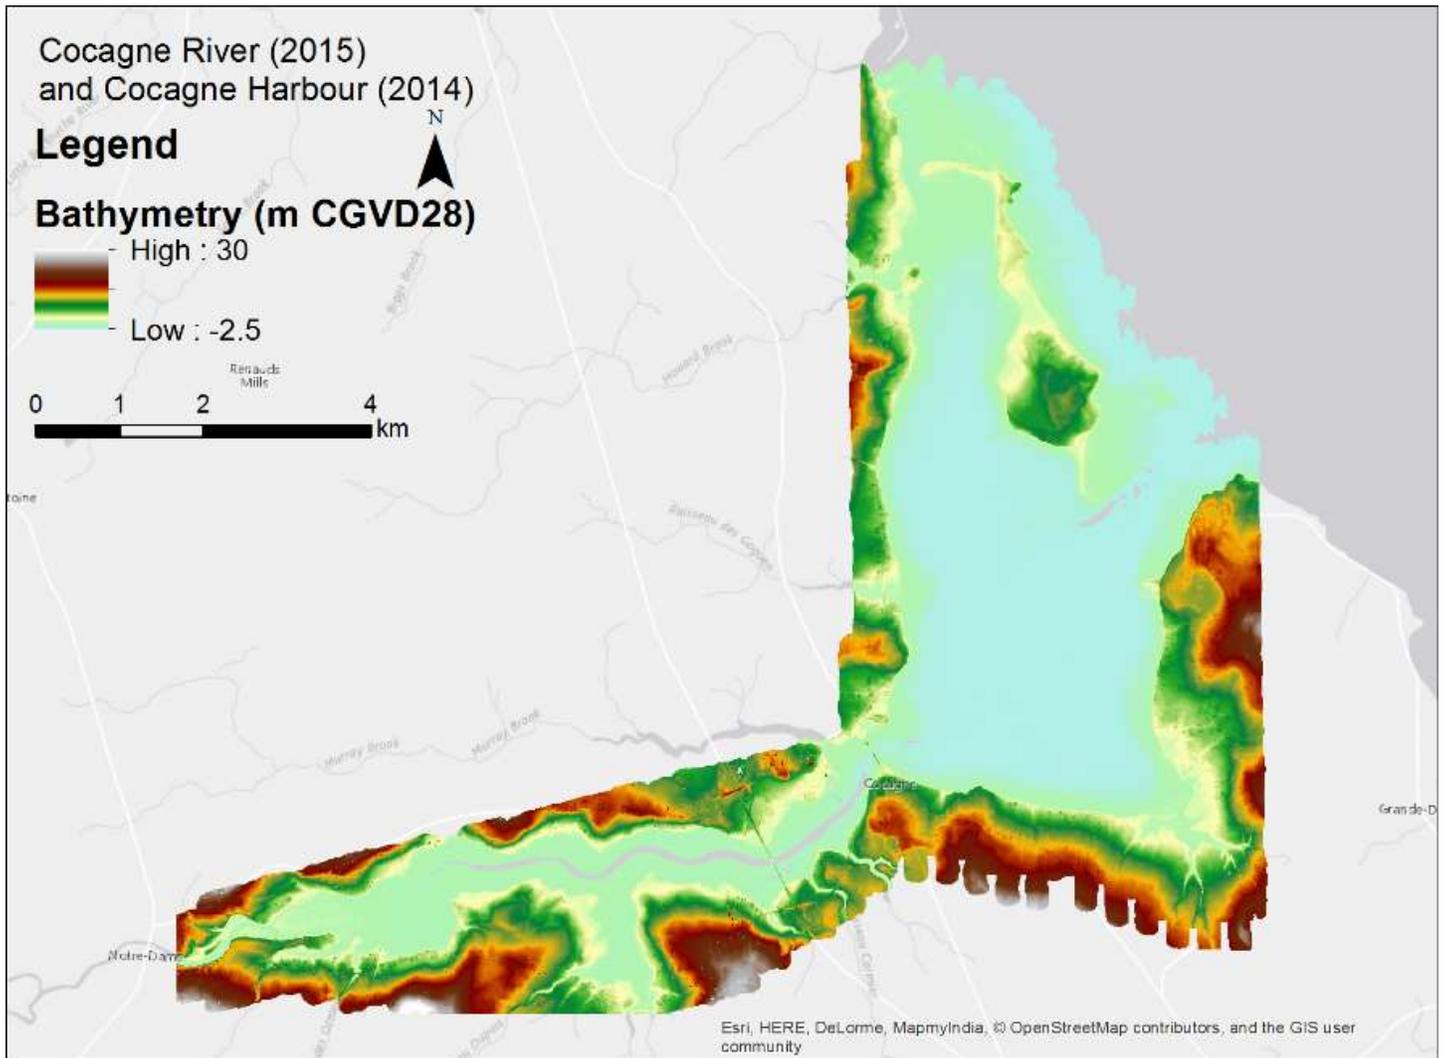
Figure 4.4: Study areas for Cocagne River, which was surveyed in 2015 for this project, and Cocagne Harbour, which was surveyed in 2014, also for DFO Gulf Region.
