Enhanced Subtidal Infrastructure Assessment to Support Inland Finfish Aquaculture

Peter Corey
Aquaculture Manager
Scotian Halibut Limited

March 31, 2017

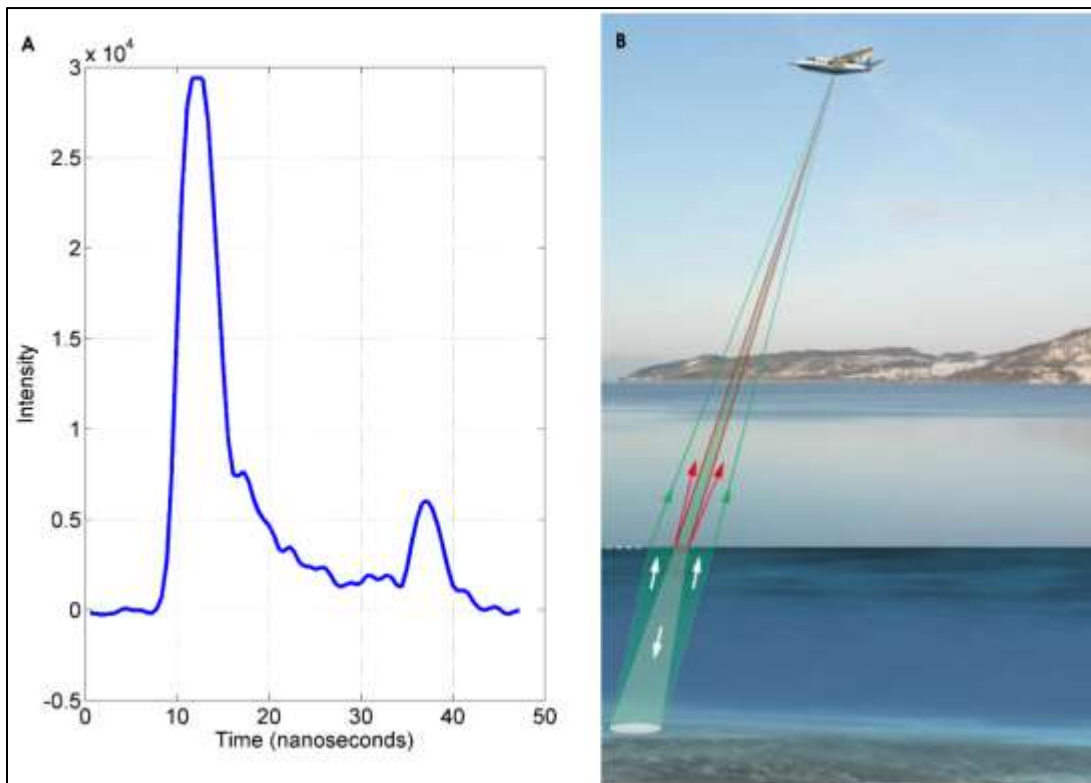
Figure 2. (A) Example of the Chiroptera II green laser waveform showing the large return from the sea surface and smaller return from the seabed. (B) Schematic of the Chiroptera II green and NIR lasers interaction with the sea surface and seabed (adapted from Leica Geosystems).

The lidar sensor used in this study is a Chiroptera II integrated topographic-bathymetric lidar sensor equipped with a 60 megapixel multispectral camera. The system incorporates a 1064 nm near-infrared laser for ground returns and sea surface and a green 515 nm laser for bathymetric returns (Figure 2). The lasers scan in an elliptical pattern, which enables coverage from many different angles on vertical faces, causes less shadow effects in the data, and is less sensitive to wave interaction. The bathymetric laser is limited by depth and clarity, and has a depth penetration rating of roughly 1.5 x the Secchi depth (a measure of turbidity or water clarity using a black and white disk). The Leica RCD30 camera (Figure 3) collects co-aligned RGB+NIR motion compensated photographs which can be mosaicked into a single image in post-processing, or analyzed frame by frame for maximum information extraction.

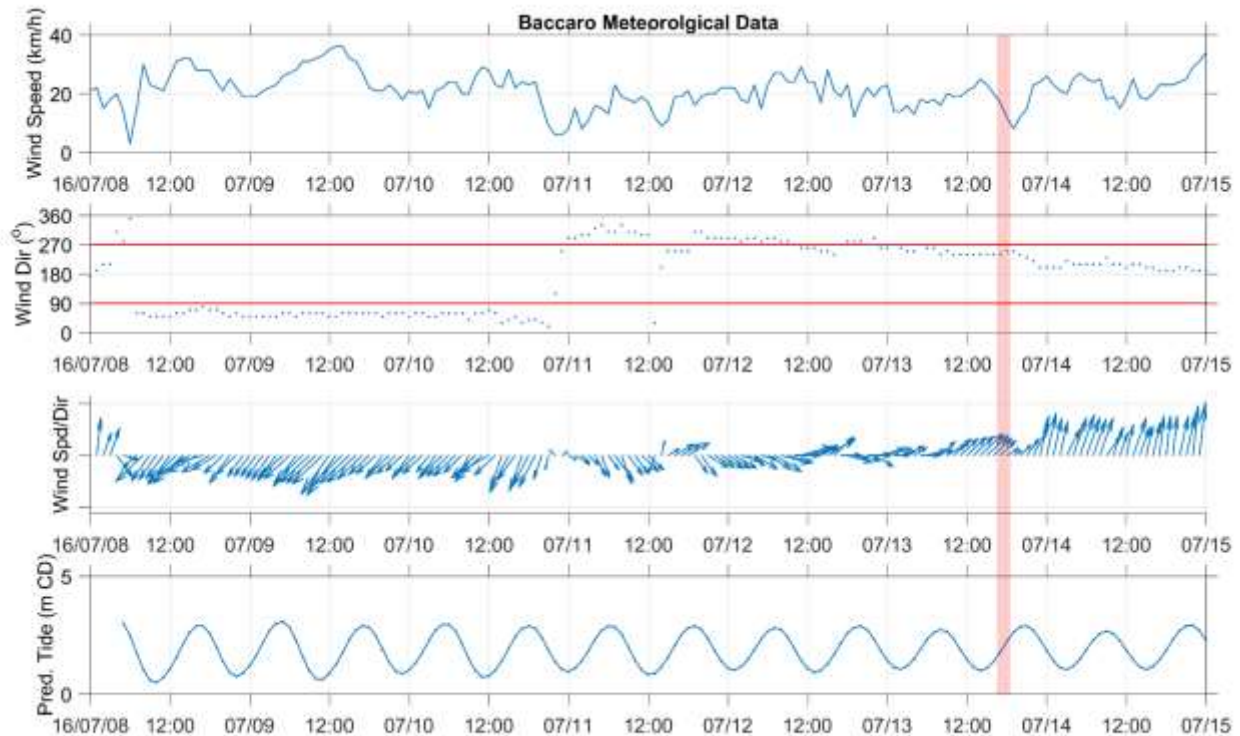
Figure 5. Wind speed (top panel) and direction (middle upper panel) collected at the EC weather station at Lower Woods Harbour (Baccaro Point) between July 8 and 15, 2016. The middle lower panel shows a vector plot of the wind, where the arrows point in the direction the wind is blowing, while the bottom panel shows the tidal stage in the area over the same timeframe. The narrow red rectangular box indicates the lidar survey duration.

Weather observations (Figure 5) are from the Environment Canada weather station at Baccaro Point and show that wind speeds leading up to the survey date were typically between 15 and 25 km/hr blowing from the northwest. The 24 hours prior to the lidar survey saw wind rotate counterclockwise from the SW, with winds during the survey blowing at roughly

15-20 km/h. These winds were blowing in an onshore direction, both leading up and during the survey, though the water was not stirred up enough to negatively impact the survey significantly as the water quality was not reduced greatly.

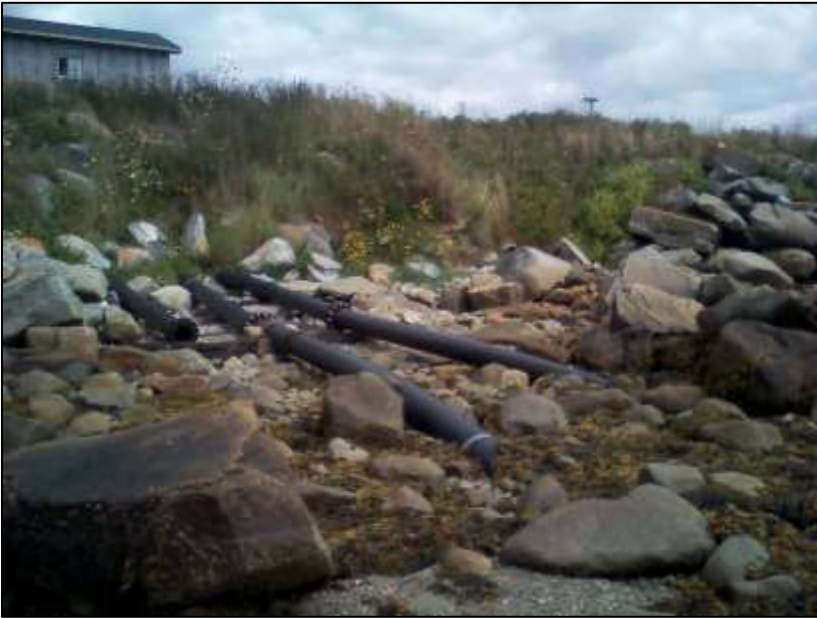
Figure 7. The on-shore extent of the pipes to be surveyed. The picture is taken looking due southeast, thus the pipe on the right is the southern pipe, and the pipe on the left is the northern pipe. Picture taken on August 15, 2016.

On August 15, 2016, AGRG consulted with Scotian Halibut regarding the project on site at the Scotian Halibut facility in Lower Woods Harbour. At that time, GPS points were taken in the area on flat, hard surfaces around the facility to compare with the elevation of the resulting elevation models. Additionally, low tide that day exposed the pipes along the shore, so GPS points were collected of the exposed portion of the pipes (Figure 7). A Real-time Kinematic (RTK) GPS system referencing a nearby active control station was used to collect the GPS data. Two additional surveys – one on September 22 and one on October 3 - were conducted to collect additional hard surface RTK GPS points as well collect the underwater video from AGRG’s 14’ aluminum boat. On September 22, issues with power supply prevented the SeaViewer underwater video camera from being used for data collection, so in lieu a waterproof GoPro camera was attached to a large pole and set to record video. On October 3 the power supply issue was resolved and video was collected with the SeaViewer video camera. While the SeaViewer video camera was connected to a handheld GPS device that provided a latitude and longitude, an RTK GPS unit was used to track the movement of the boat for a more accurate location. The boat survey attempted to gain confirmation of the pipes by observing the location of the pipes on the seabed. Numerous transects were completed over the suspected locations of the pipes (Figure 9), and subsequently the underwater video was used to construct points where the pipe was located (more about this in Section 2.3).

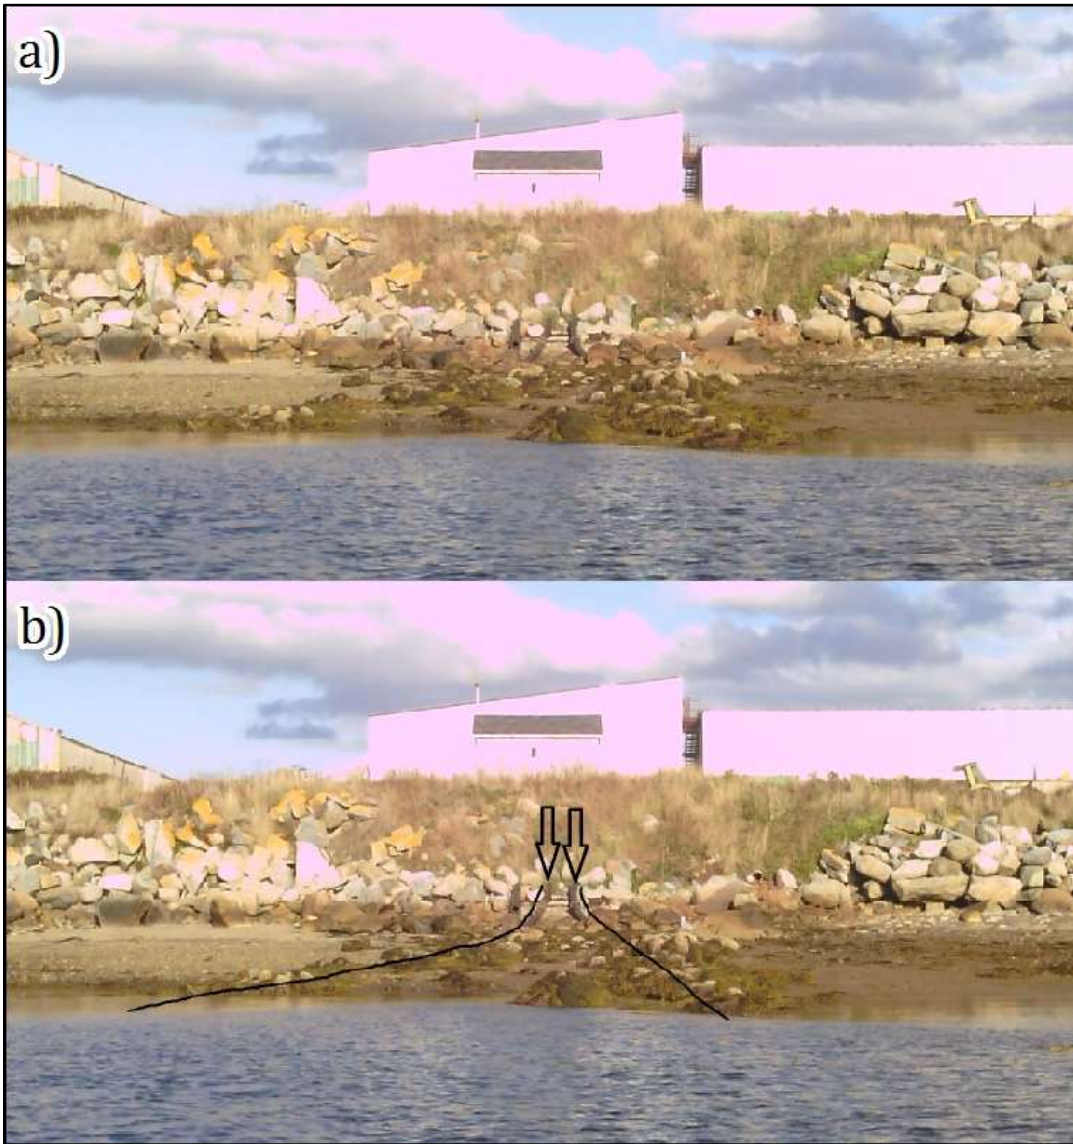
Figure 8. The pipes are exposed at low tide, as can be seen in this picture (a) and outlined (b) taken from the water on Oct 3. In these images the northern pipe is on the left and the southern pipe is on the right.

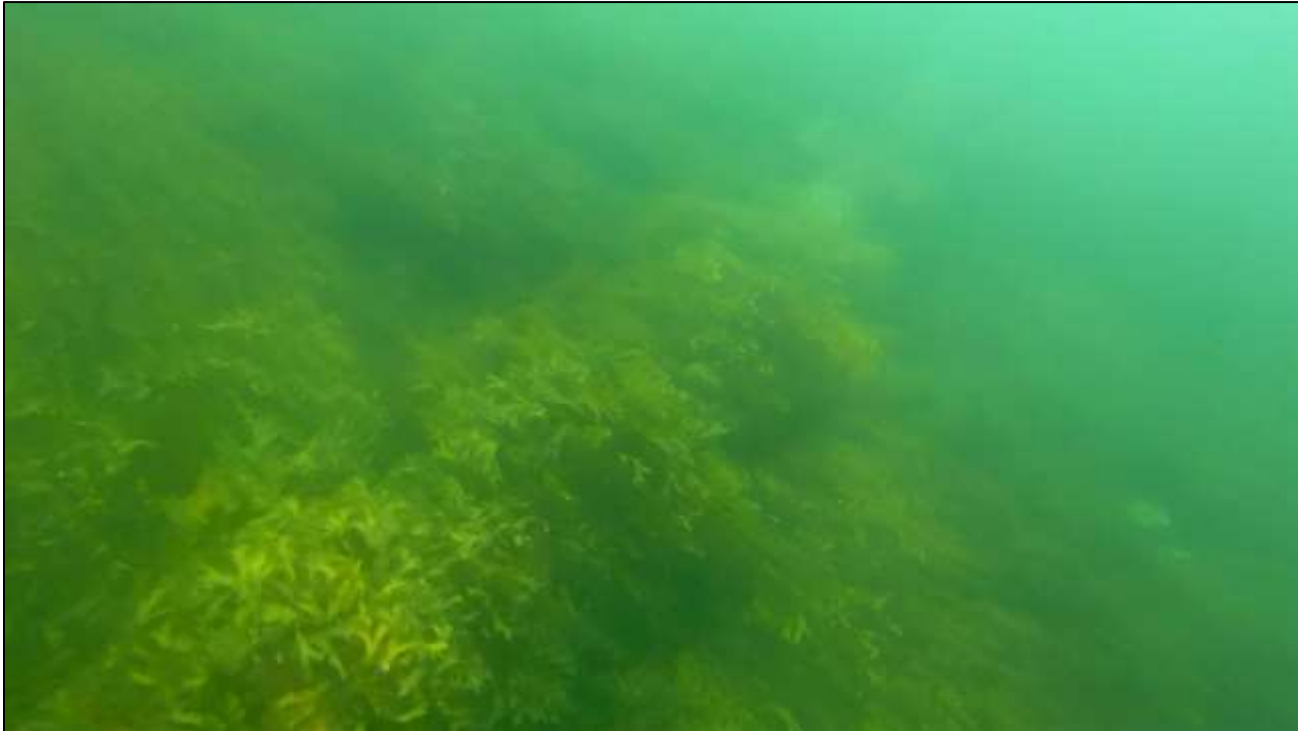
Figure 10. A screenshot of the southern pipe taken from the underwater GoPro video collect done on September 22.

Each video segment was watched and assessed visually for signs of the pipe. The moment the boat drove over the pipe, as evidenced in the video (Figure 10), the corresponding RTK GPS point was selected and treated as a confirmed location. As can be seen in this figure, the pipe is covered with a thick mat of fucus and other submerged aquatic vegetation.

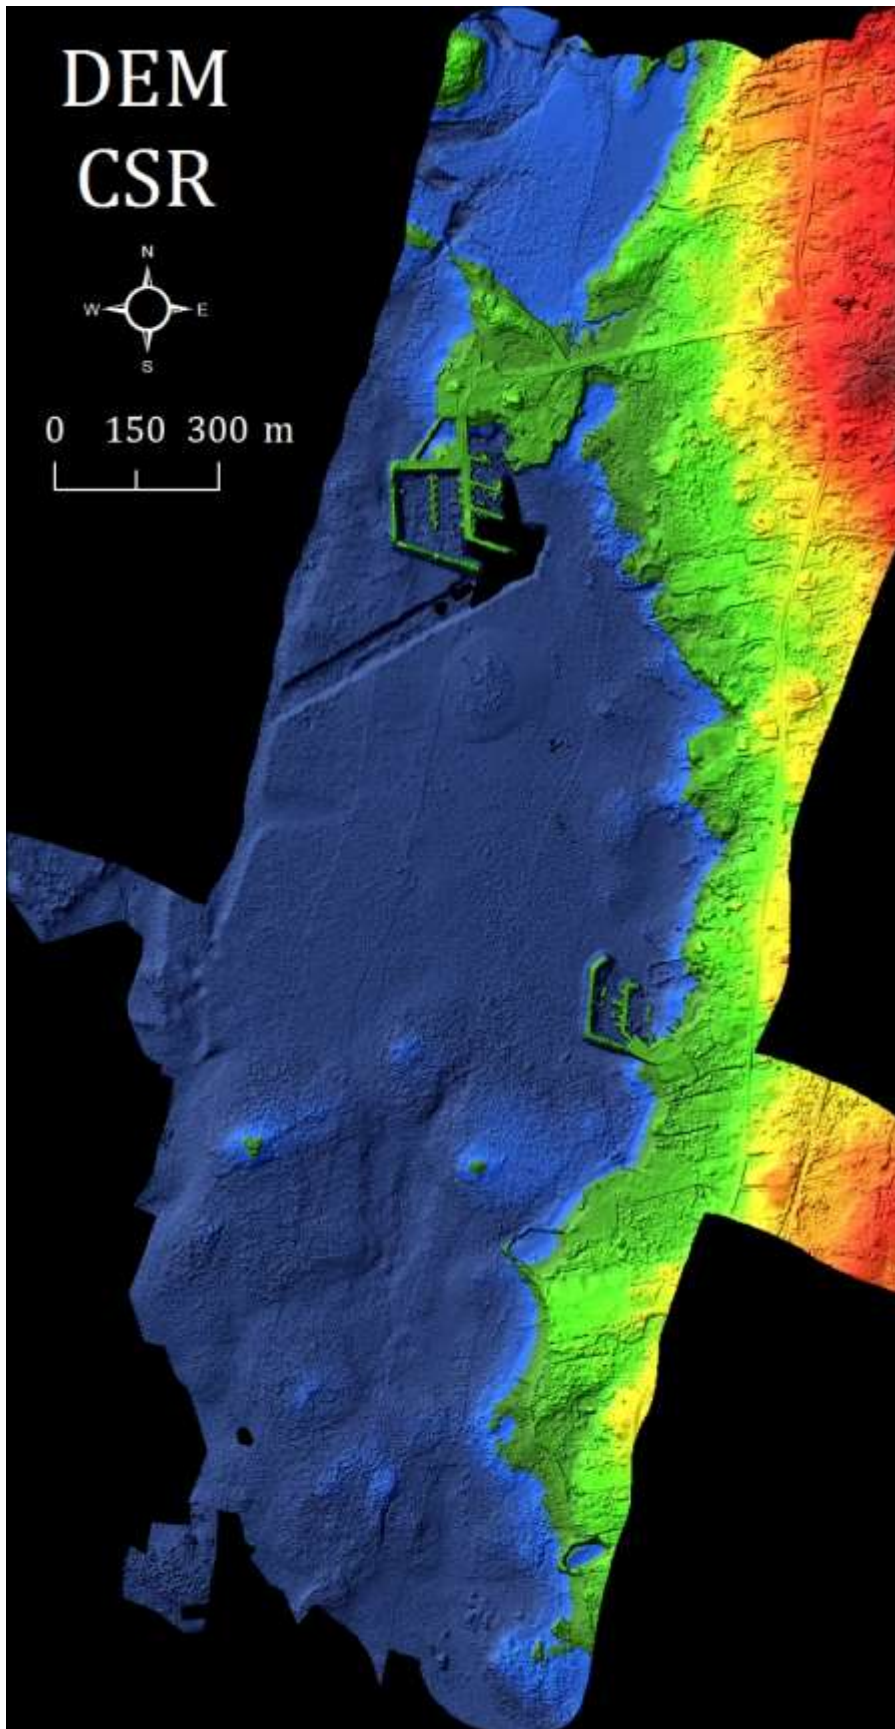
Figure 11. An elevation-coloured hillshaded relief of the digital elevation model.

This section presents Colour Shaded Relief Models (CSRs) for the DEM (Figure 11) and DSM (Figure 12) for the whole study area. Figure 13 shows the 0.05 m true-colour composite imagery collected at the same time as the lidar survey using an RCD30 camera system. The lidar penetrated to -10.6763 m CGVD28 near the outer harbour and in the channel leading into the Lower Woods Harbour wharf, which is equivalent to -11.747 m in depth during the lidar survey (Figure 14). The DNI for the study area is shown in Figure 15.

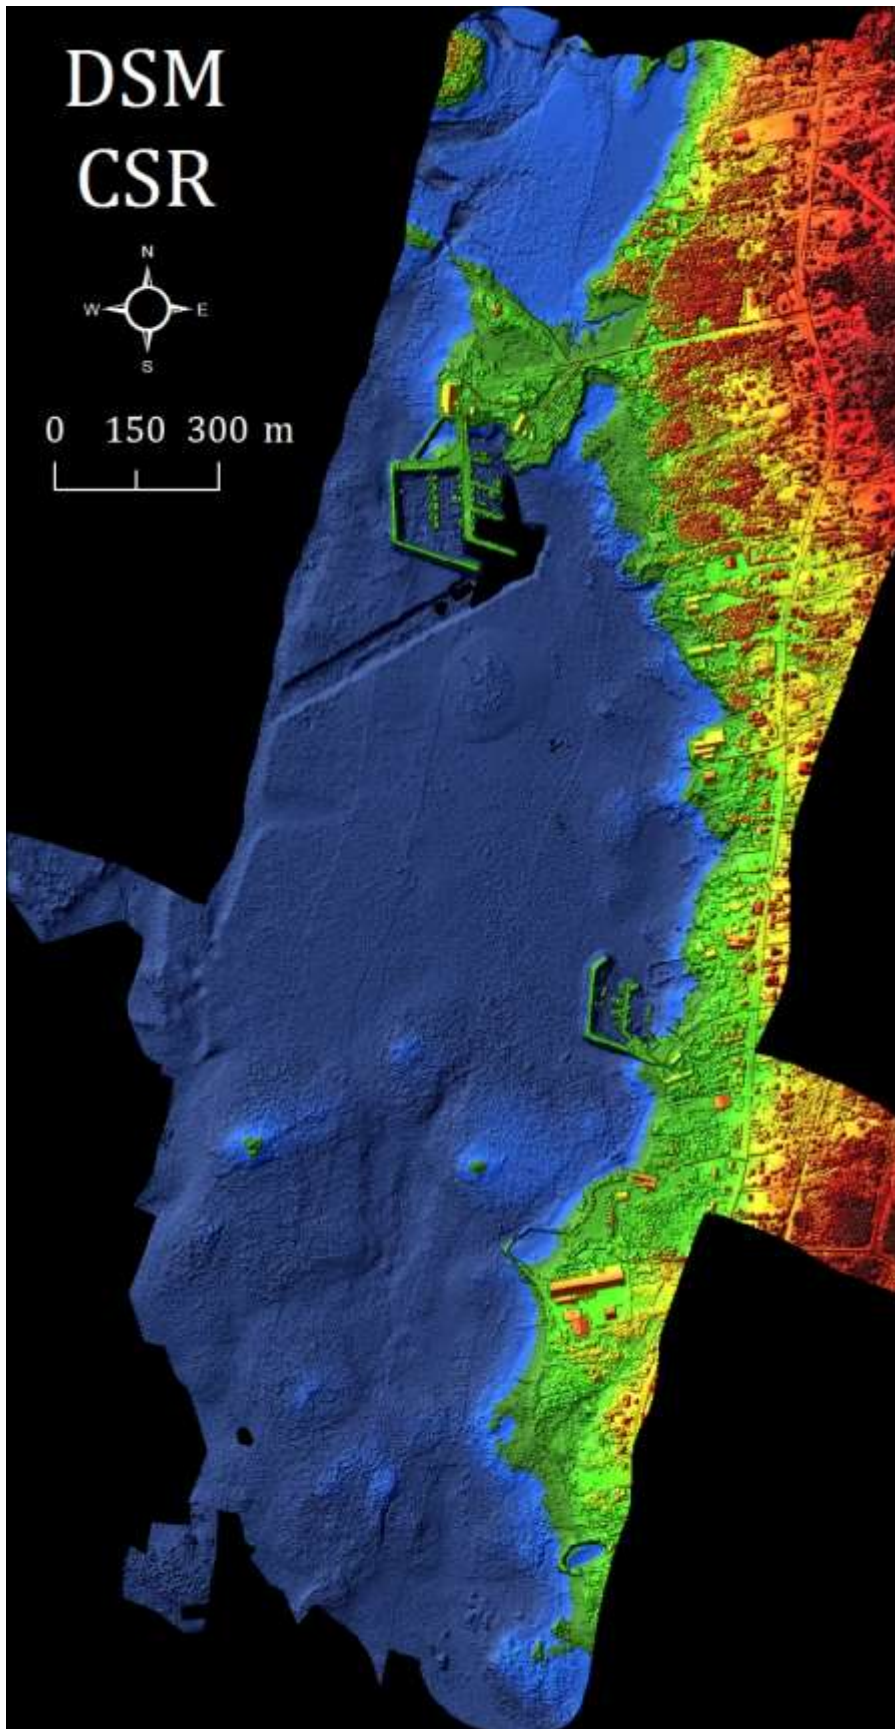
Figure 12. An elevation-coloured hillshaded relief of the digital surface model.

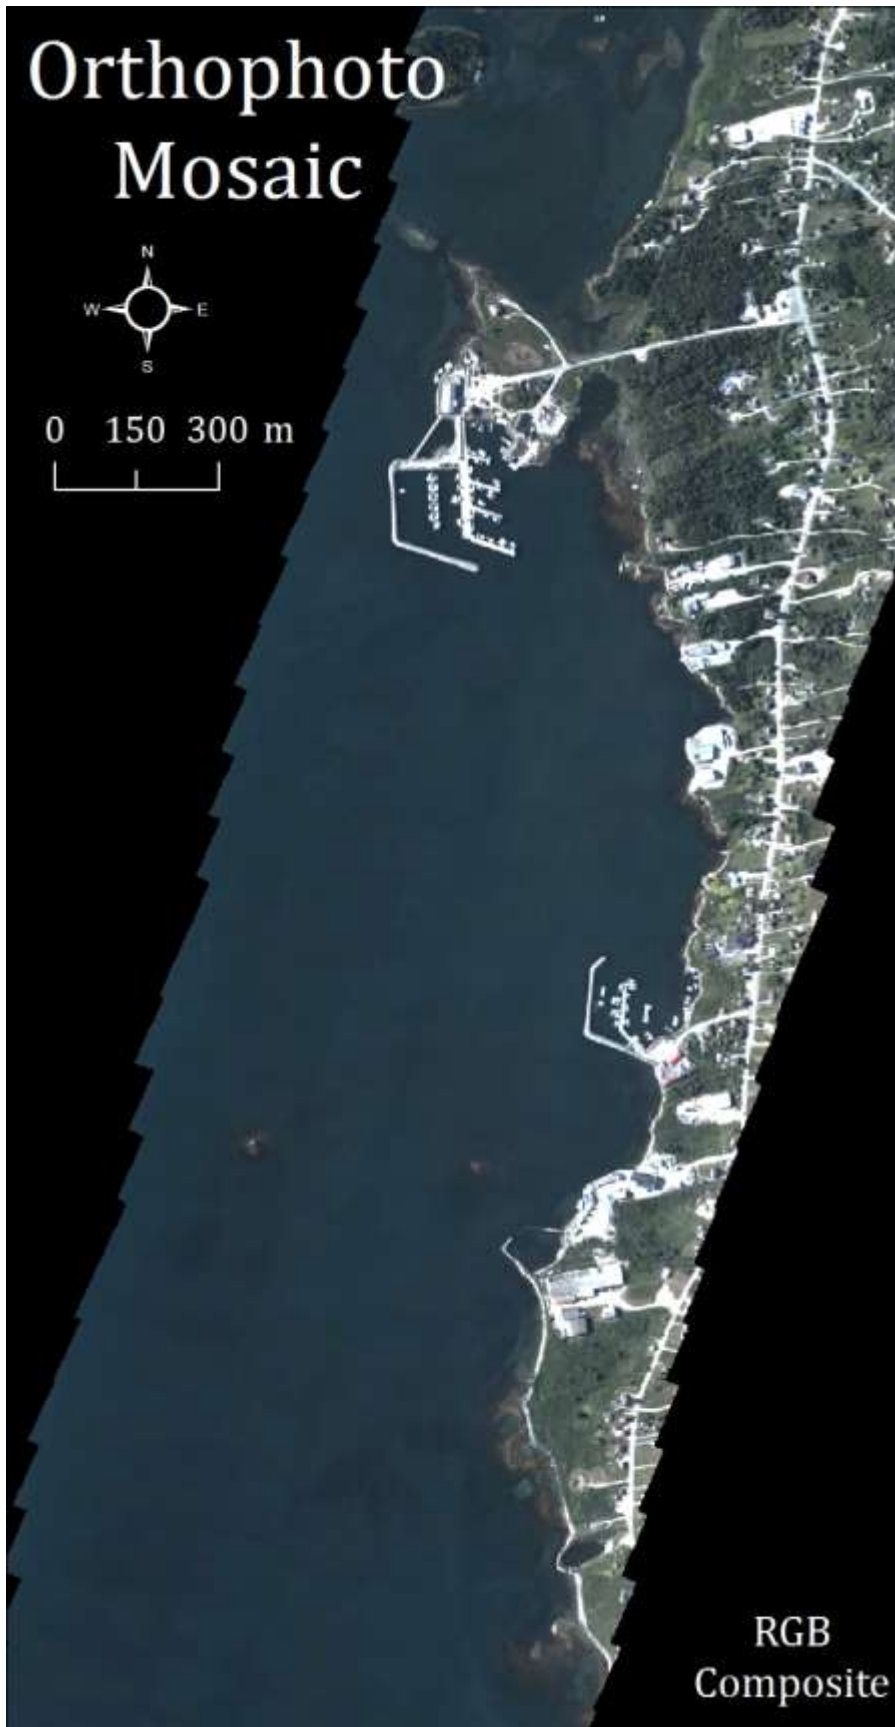
Figure 13. A true colour composite of the 0.05 m RCD30 aerial photo orthomosaic collected during the lidar survey on July 13, 2016.

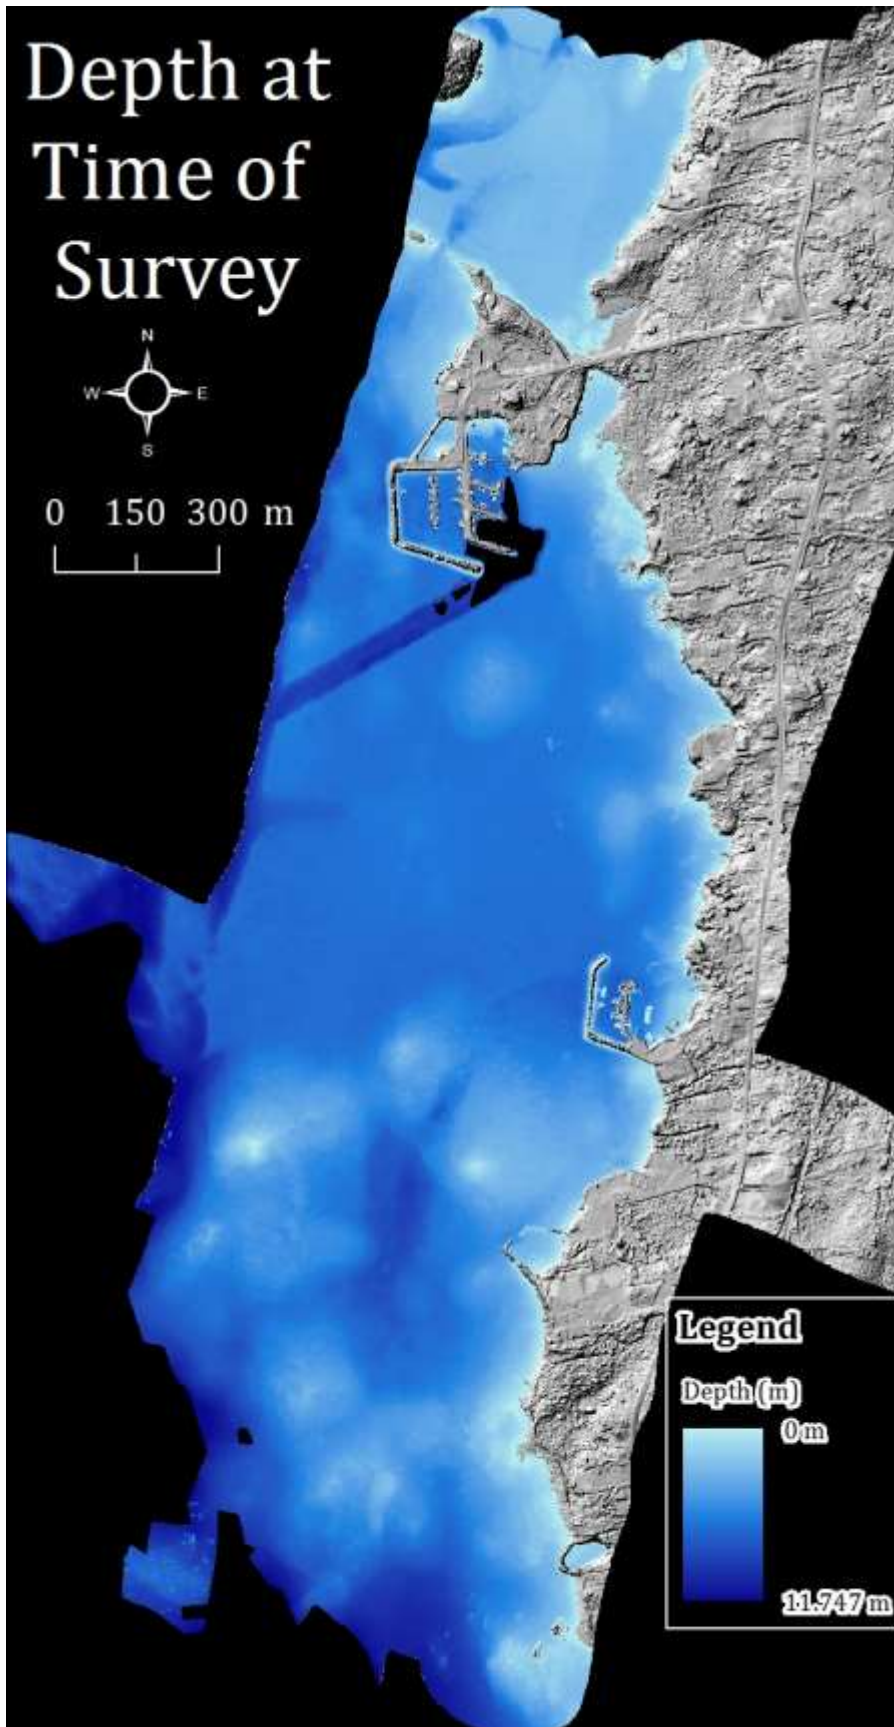
Figure 14. The depth of the water at the time of the lidar survey on July 13, 2016 shows the lidar penetrated a maximum of 11.747 m. The depth information here is shown on the greyscale hillshade of the DEM.

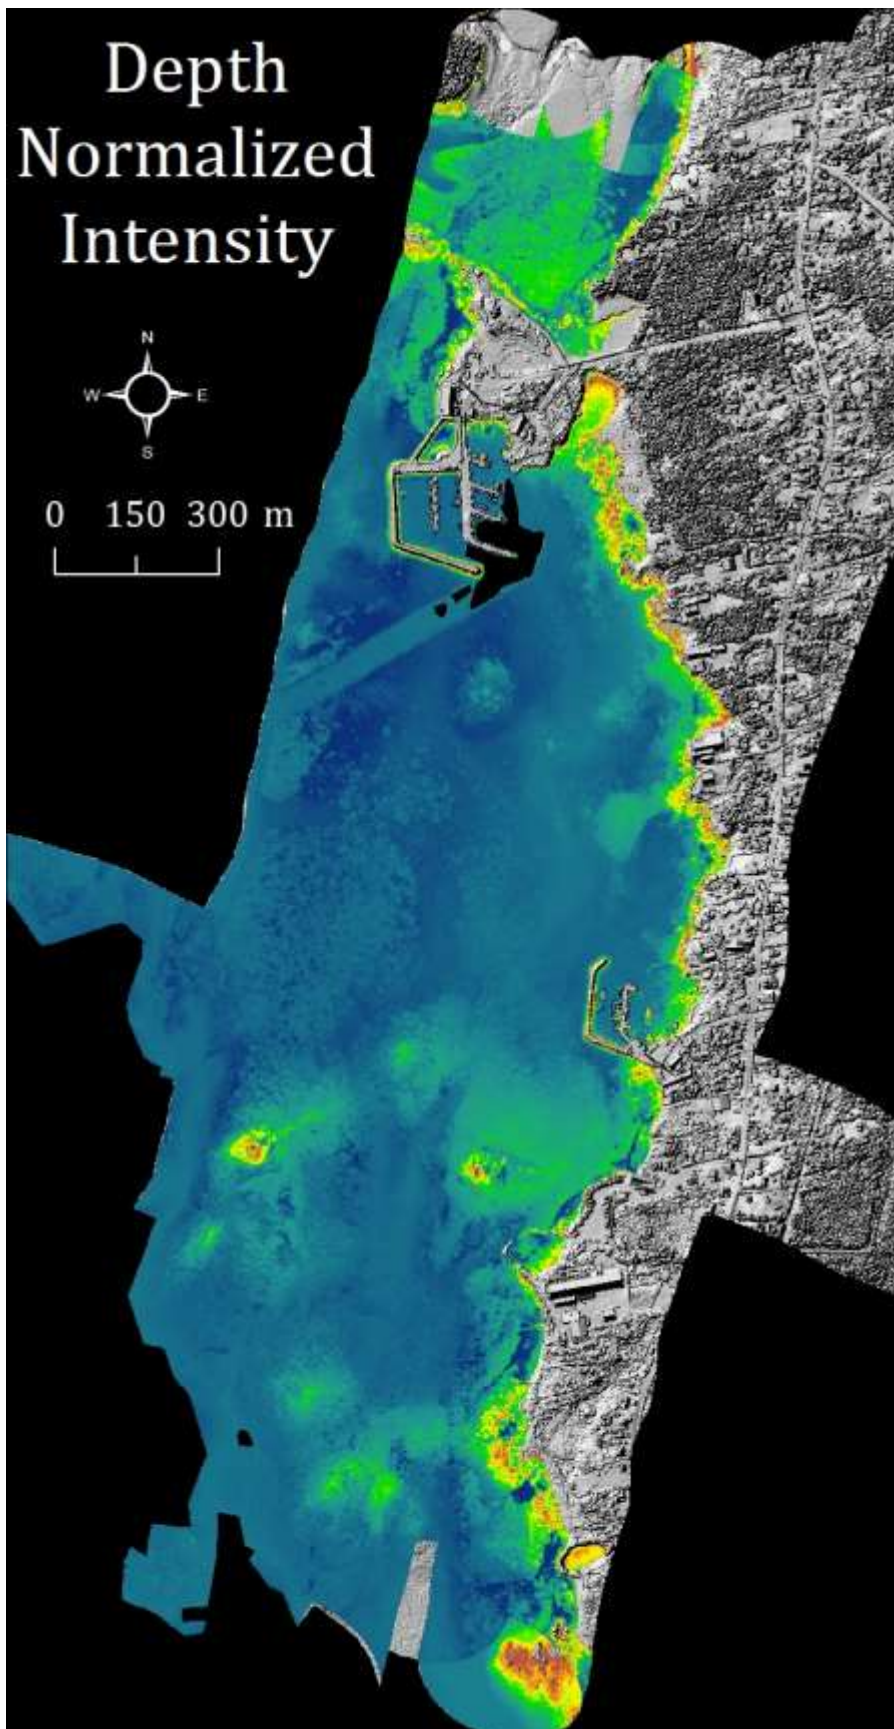
Figure 15. The depth normalized intensity for the study area. The depth information here is shown on the greyscale hillshade of the DSM.
